Report on environmental pollution by Monnet Daniel Washery situated at Khalari Block of Ranchi District, Jharkhand in the matter of Krishna Chouhan Vs State of Jharkhand in O.A. No. 479/2022 pending before Hon'ble National Green Tribunal, Principal Bench, New Delhi.

Photographs taken during inspection on 26.09.2022

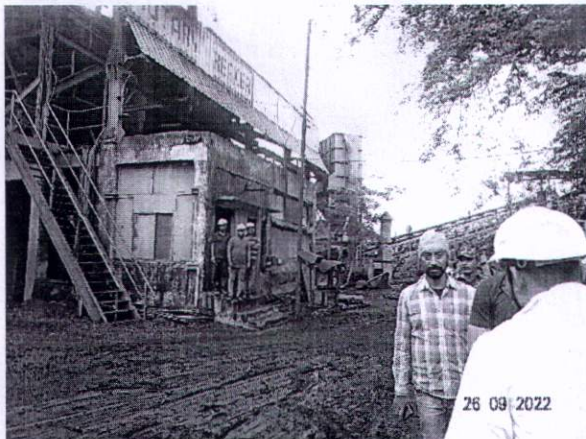
Photo 01: Photo of Pollution control equipment attached to the coal transportation circuit in project

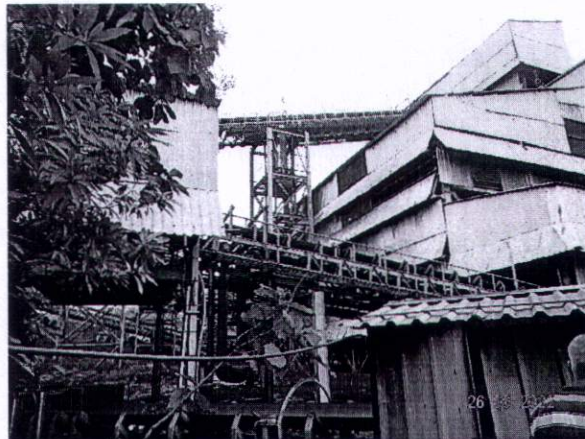
<p>iii. The above said Project Proponent is continuously violating provisions of the Air (Prevention and Control of Pollution) Act, 1981 and</p>	<p>a. Conveyor belts in the projects used for coal transportation were found to be uncovered and were potential source of fugitive coal dust emissions (see photos 02, 06, 7, 17, 18, 19, 21).</p> <p>b. Wall in the north east and east direction (wall inside which coal stock was kept) was observed to be broken at many places and some inadequate arrangement (metal sheets at some places and fabric sheets at other places, etc.) were done to prevent coal spillage (see photos 9, 10, 11, 12, 13). However, there were every chances of coal spillage from there and also coal dust flow outside the premises. Coal dust, broken coal were found in the road adjacent to the broken wall there (see photo 08). Once dry there can be coal dust pollution on the road (see photo 8).</p> <p>c. Some plantation was observed around the boundary of the project but there were gaps between those plantations (see photos 37).Some Plantation was observed inside the project area also (see photo 41).</p> <p>d. PM₁₀analyser was observed near the main gate of the project (see photo 40). PP</p>

Photo 02: Photo of uncovered conveyor belts for coal carrying in the project

<p>further in the project.</p> <p>f. Number of mobile water tankers should be increased. Copy of the log book of water tankers mentioning running hours, kilometer travelled, maintenance hours should be maintained.</p> <p>g. All the conveyor belts in the project should be covered urgently.</p> <p>h. Plantation/green belt development around the project boundary, in the gaps between already existing trees, inside the project areas should be developed.</p>
--	--

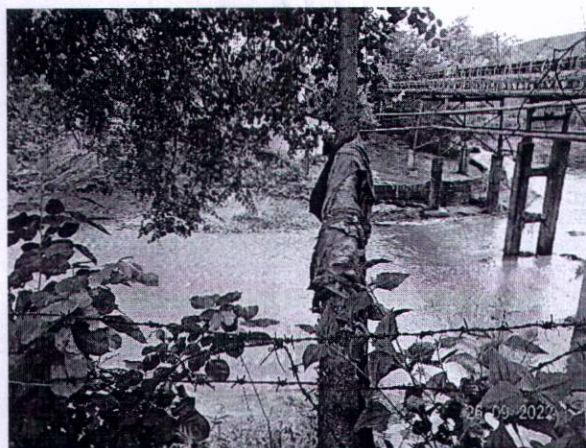
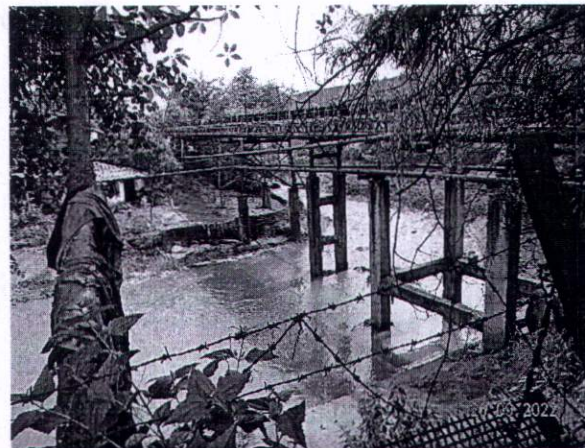
Photo 03& 04: Photos of broken wall/hump along Sonadubi nallah/river.

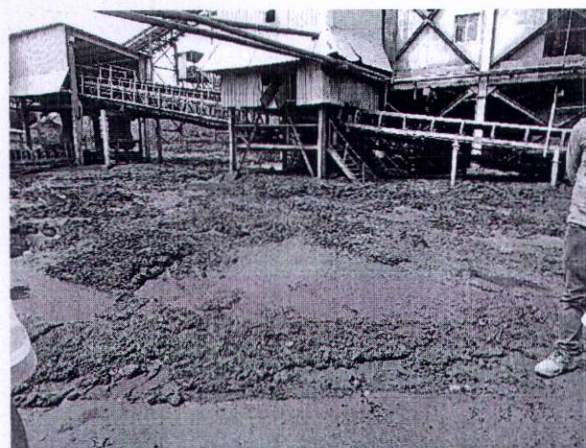
Photo 05: Photo of coal rejects(waste) from washery without any safeguards the project

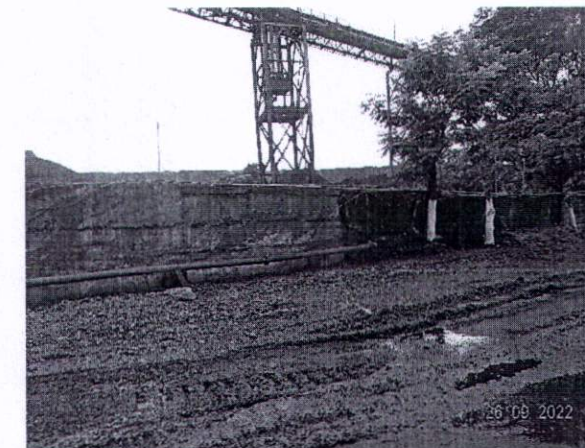
Photo 06: Photo of uncovered conveyor belts in

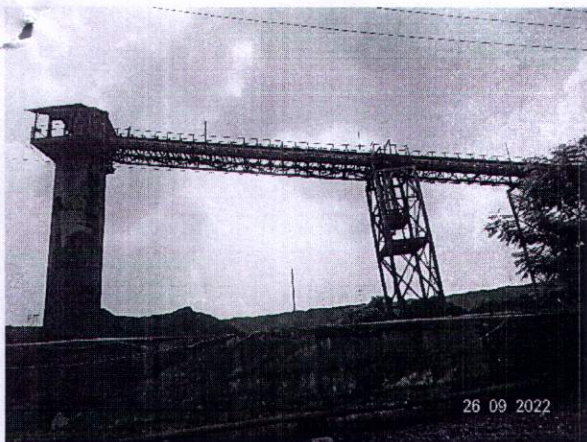
Photo 07: Photo of uncovered conveyor belts in the project. adjacent to the project wall in North

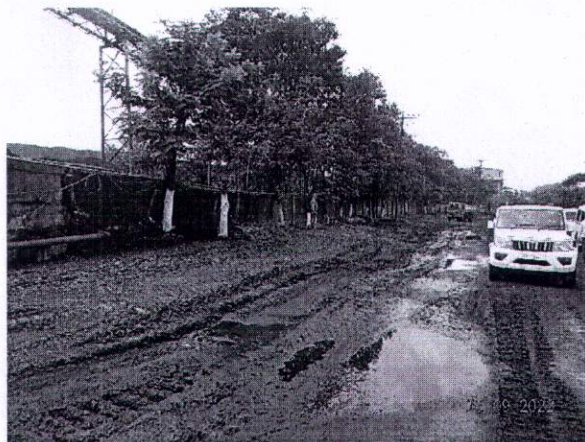
Photo 08: Photo of coal dust /debris on the road East direction

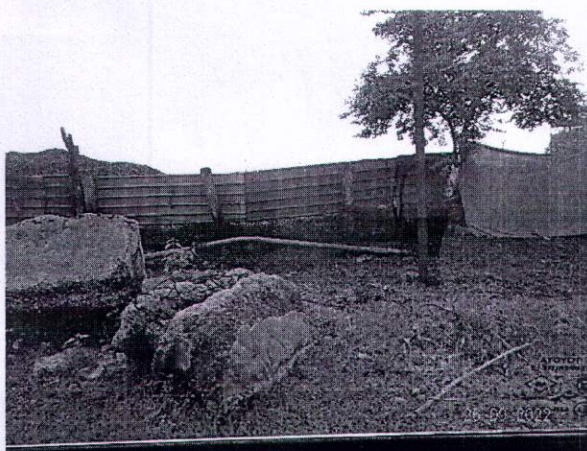
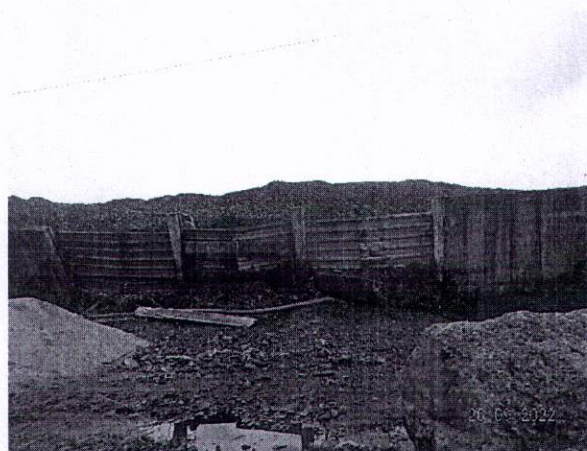
Photos 09& 10: Photos of temporary arrangement (metal sheet used) in place of broken wall in the north east direction of project. Coal dumps can be seen inside.

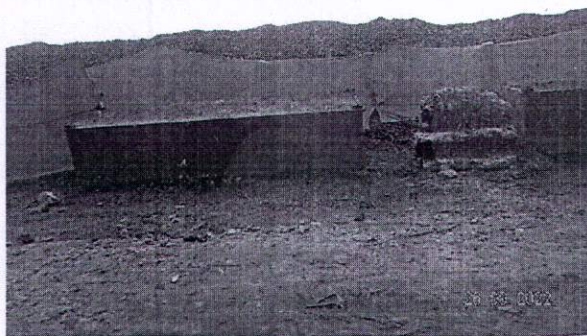
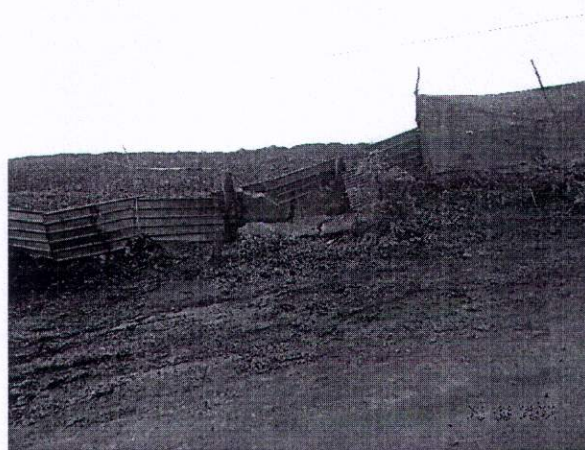
Photo 11& 12: Photos of fabric sheets and metal sheets used in place of broken wall in the north east direction of project. Coal dumps can be seen inside.

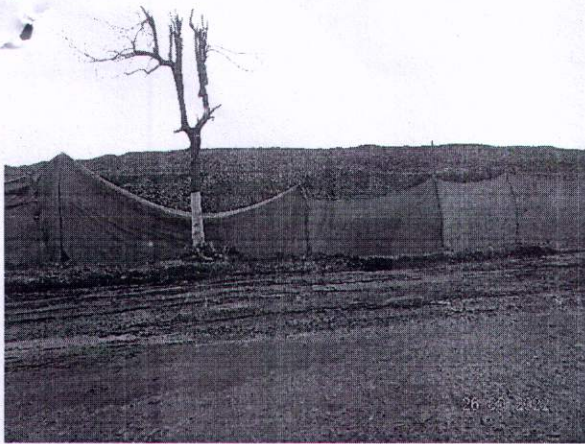
Photo13:Photo of fabric sheets used in place of broken wall in the north east direction of projectthe

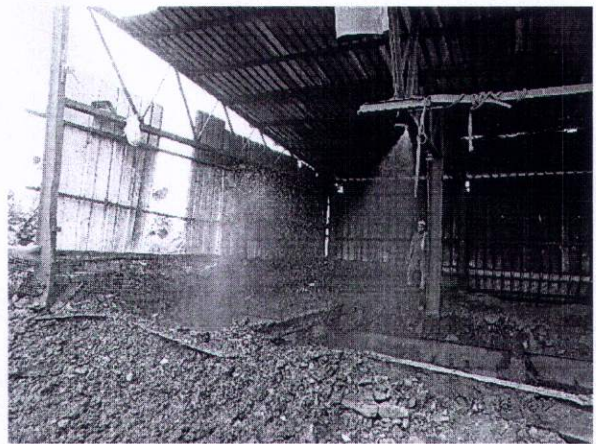
Photo14:Photo of water spraying arrangements at Coal hopper of project.

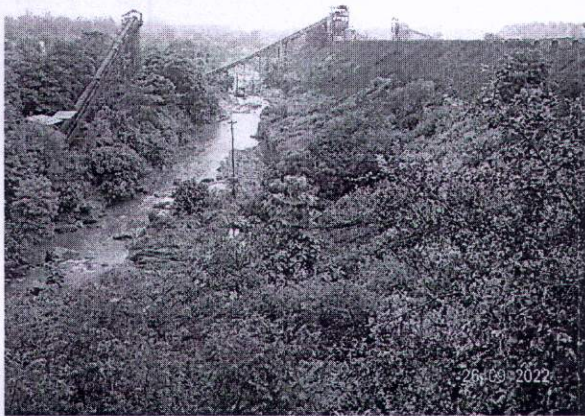
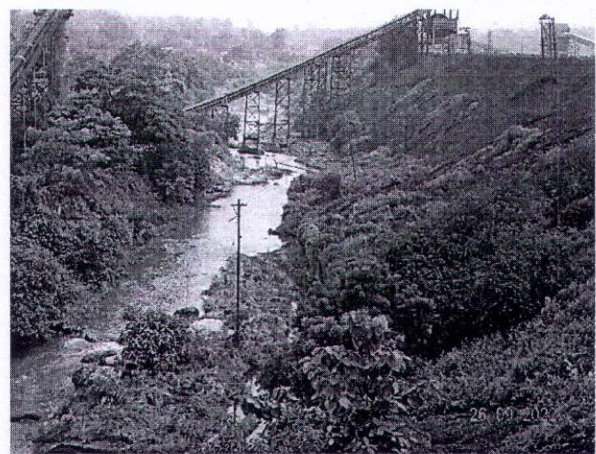
Photo15&16: Photos of Sonadubi river flowing in between project & railway siding. Coal on slope adjacent adjacent to Railway siding can be seen. Some portions of wall in between coal and river can also be seen.

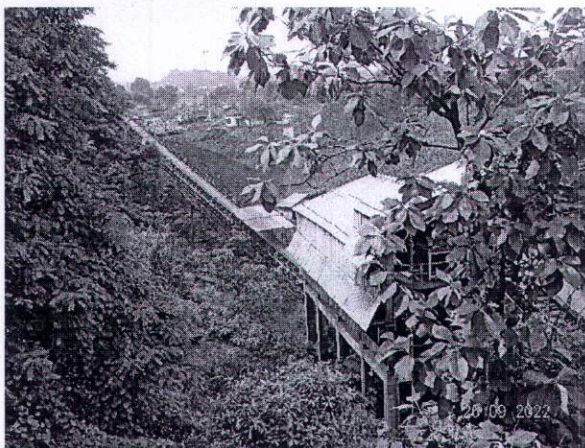
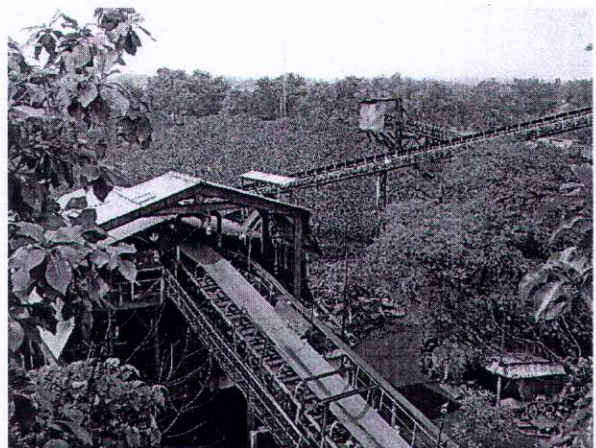
Photo 17&18: Photos of uncovered conveyor belts and coal stocks in the project.

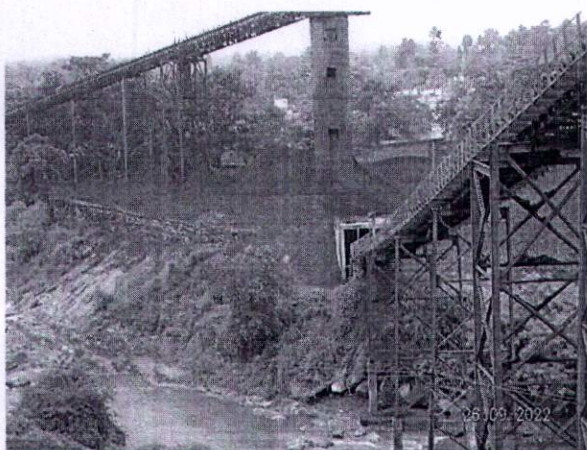
<p>form that side (see photos 19,20,22,24). However during inspection on 26.09.22 colour of water flowing in Sonadubi river was not black.</p> <p>f. On the opposite bank of the Sonadubi river i.e. toward washery side, wall was constructed between the coal stock and the river (see photos 19,20,21,23,25) but wall was broken at many places(see photos 21,23,25).Coal spillage was observed beyond the wall towards the Sonadubi river side also(see photos 21,23,25,). Water coming from coal stock to river can be seen at a place (see photo 25).</p> <p>g. Catch drains, siltation ponds were not observed around the coal stocks in the project.</p>
III	<p><u>Recommendations made by the committee members:</u></p> <ol style="list-style-type: none"> The observations /inspection report is being sent to concerned divisions of MoEF&CC, HQ, New Delhi for necessary action as deemed fit as per acts and rules (report shall be sent by IRO Ranchi to MOEF&CC New Delhi) Regional Officer, Ranchi, JSPCB(Jharkhand State Pollution Control Board is also sending the committee report to JSPCB Member Secretary for necessary action. <p>Committee members instructed the Project Proponent verbally for remedial actions at the site during their inspections on 26.09.2022. Some of the important instructions were:</p> <ol style="list-style-type: none"> Comply all the conditions of EC issued by MoEF & CC and CTE/CTO issued by JSPCB. Clear/ take out all coal from the slopes adjacent to Sonadubi nallah/river. Develop grassing and vegetation around the slopes of the river. It should be ensured that during loading /unloading of coal at the railway siding no coal is spilled on the slopes facing the Sonadubi river/nallah. Construct and repair broken wall between Sonadubi river and project urgently. Bring all the coal stocks inside the premises urgently and construct/ repair all the wall around project boundary (in all the directions). Make catch drains, siltation's ponds, concrete humps/wall around coal dumps, washed coal, rejects so as to ensure that no coal dust/slurry flows in river/ other low lying areas. Arrange for repair and maintenance of all roads in and adjacent to the project. It should be ensured that there is no coal spillage on the coal transportation roads. In case of any sudden spillage the coal, broken coal should be cleared/cleaned within same day. Tarpaulin covering on the coal transportation trucks should be done strictly. An office order in this regard should be issued that if any truck is found without tarpaulin covering during coal transportation it would not be allowed to operate

Photo 21: Photo of wall broken and coal beyond project boundary adjacent to Sonadubi river

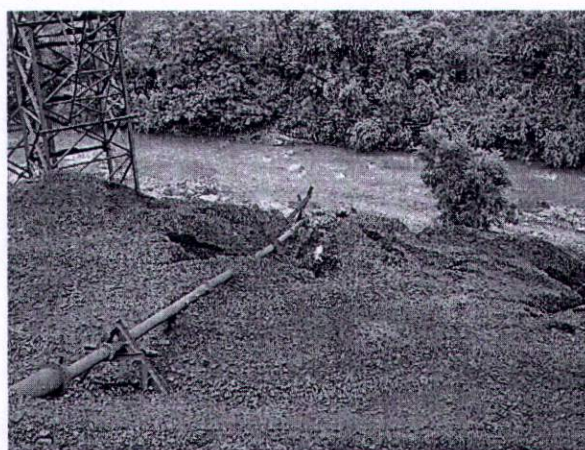
Photo 22: Photo of coal from railway siding area fall towards river/nallah

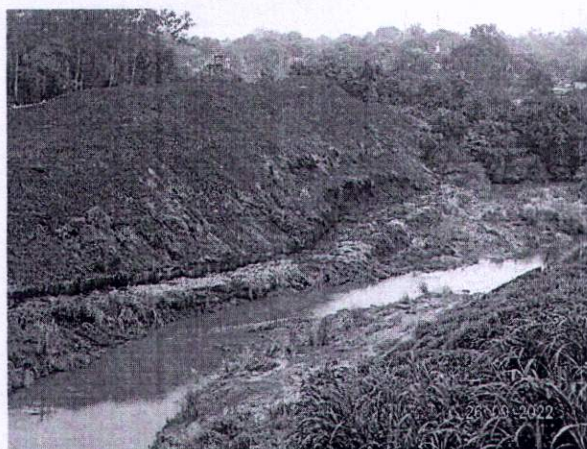
Photo23:Photo of wall broken/coal breach beyond project walls adjacent to Sonadubi river/nallah.

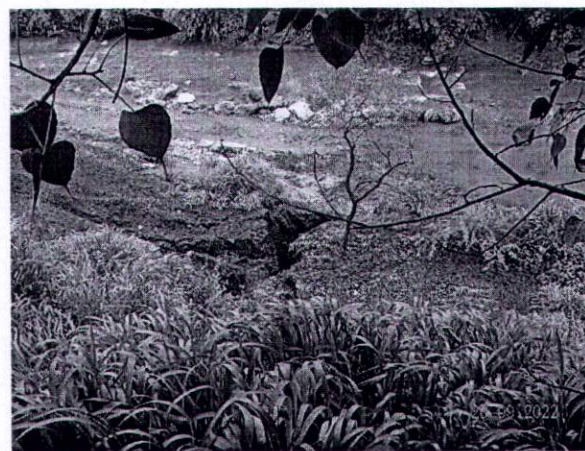
Photo24:Photo of a close view of coal spill towards Sonadubi river from project railway siding

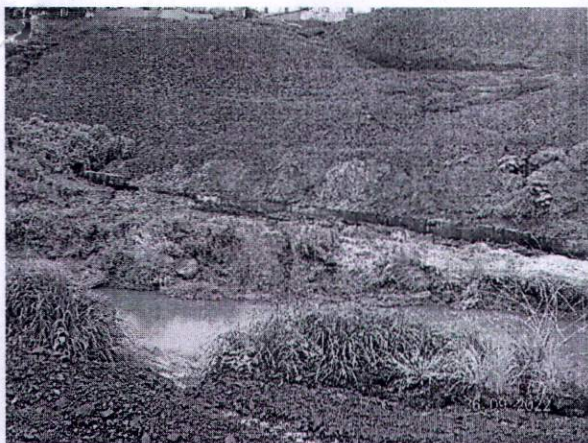
Photo 25: Photo of wall broken/coal breach and water coming from project wall sideto Sonadubi river.

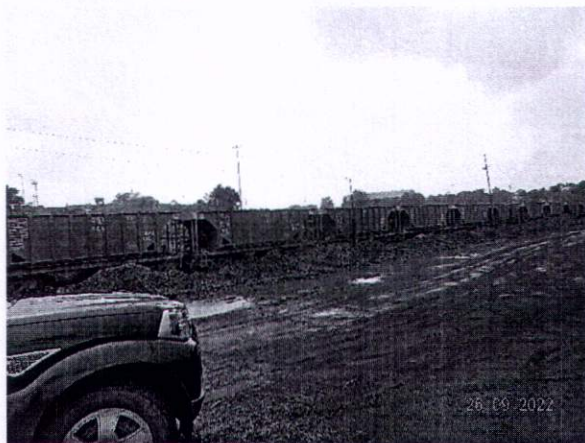
Photo 26: Photo of operational fixed water sprinklers at the railway siding

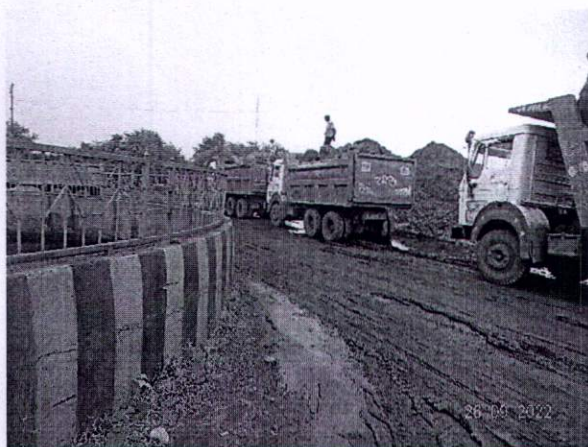
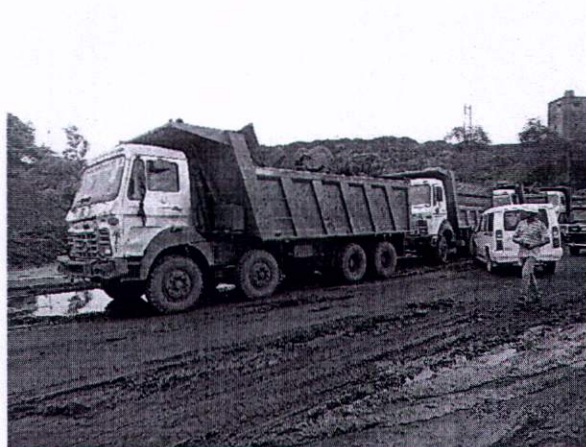
Issues raised by the complainants/applicant	Observations of inspecting team/committee members
i. Project Proponent has stored heavy quantity of rejected coal in Monnet Daniels Coal Washery situated in the area of KDH in Khalari Block of District Ranchi and has also blocked the road near KDH weighment bridge with coal sludge.	<p>a. Large quantity of coal was stocked in the project (see photo 07, 08, 10, 12, 17, 18, 43) whereas in the EC(Environmental clearance) it is mentioned that "Only one day stock shall be stored in the stockyard (specific Condition(ii) of EC accorded by MoEFCC vide no. J-11015/260/2008-IA.II (M) dated 10.12.2008. As per the data submitted by the project proponent raw coal stock-610.27MT, washed coal stock 432.03MT and Reject coal stock-43842.75MT as on 25.09.2022. The details submitted by the PP is attached as Annexure-I.</p> <p>b. In the north, north-east direction of the project and near the weigh bridge area coal stock was observed outside the project boundary area (i.e. at some places 5 to 6 mt. beyond the project boundary area - see photos 33,34). Boundary wall was broken there and coal was found 5-6mt beyond the project boundary and occupied a portion of the road there. Coal dust and broken coal was observed on the road in that direction (see photos 33,34) that was a potential source of air (coal dust) pollution. A long jam of trucks was observed near the weighbridge area (see photo 33, 34).</p> <p>c. Tarpaulene covering was not observed over the coal transportation trucks that brought coal from</p>

<p>mines to washery(see photos 27,28,29).Project authorities explained that at a security check post in between mine and washeryTarpaulene covering is opened and then many truck operators may not be covering tarpaulene after that point. However, there was thick coal dust layers on the road (see photos29, 30) due to coal spillage from trucks. Also coal was stocked outside the coal project boundary in that area (north west direction to the project (see photos 27,28,32) and at some places till the roads.</p>
<p>ii. The rejected coal stock caught fire which is emitting smoke adversely affecting health of the residents of the locality.</p>	<p>Committee members did not observe smoke or spontaneous combustion in the coal stock at the project. However such a large coal stock can be a potential source of spontaneous combustion/smoke. May be due to rainy season there was no spontaneous combustion/smoke in the large coal stock stored in the project.</p>

Photos 27& 28: Photos of no tarpauline covering over coal transportation trucks to the project.

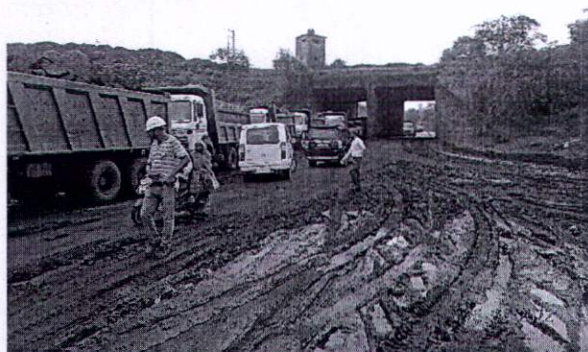
Photo 29: Photo of coal dust layers on the coal transportation road adjacent to the project

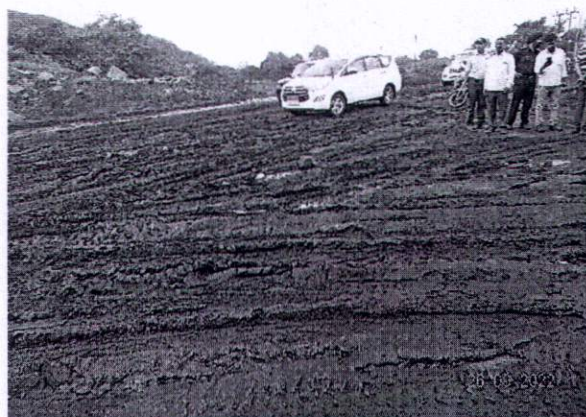
Photo 30: Photo of coal dust layers on the coal transportation road adjacent to the project

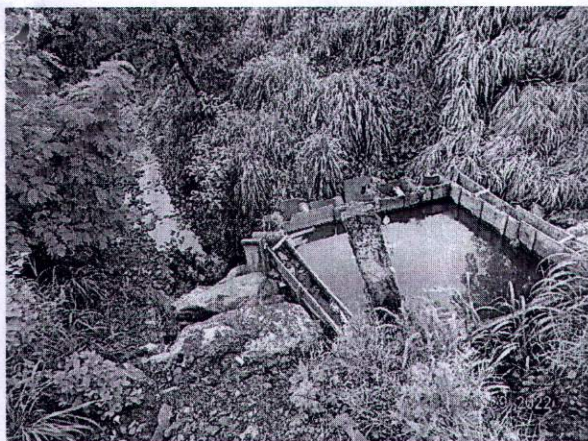
Photo 31: Photo of a sedimentation pond in between railway siding and the project

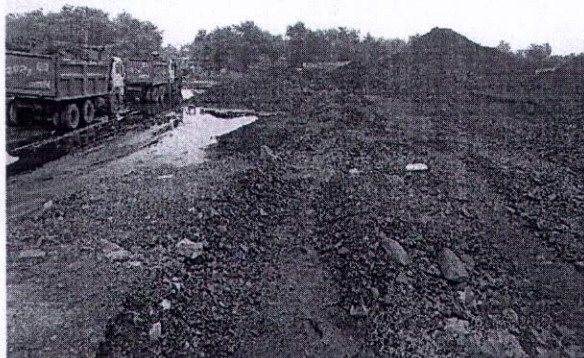
Photo32:Photo of coal stock kept in the project in north west and north direction beyond boundary

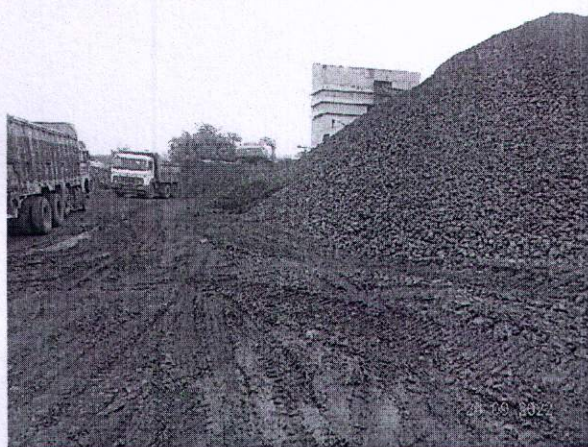
Photo33:Photo of coal stock kept in the project north east direction beyond boundary.

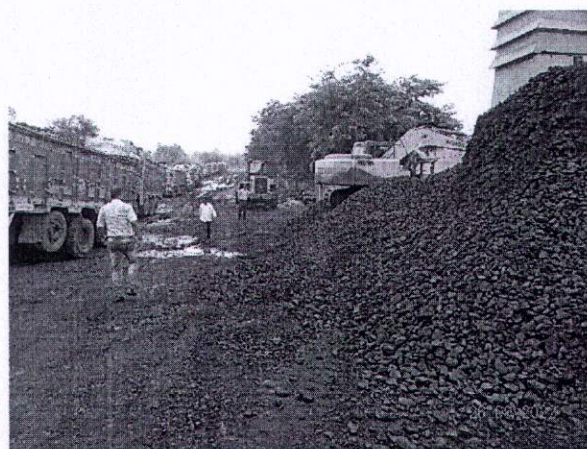
Photo34:Photo of coal stock kept in project in north east direction beyond boundary(truck jam on road visible)

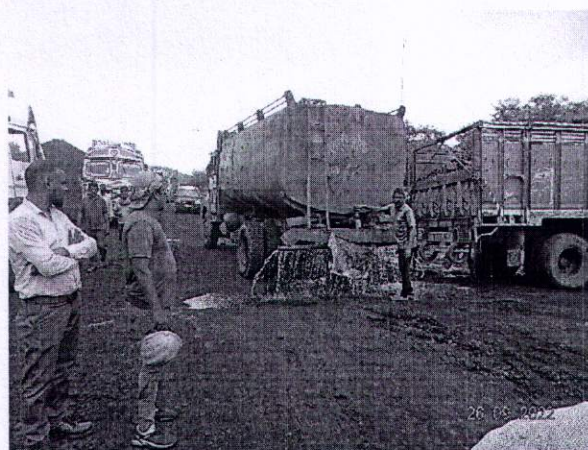
<p>informed that PM₁₀ analyser was connected to JSPCB (Jharkhand State Pollution Control Board) server.</p> <p>e. A water tanker was observed sprinkling water on the road in the north direction of the project (see photo 35). Project authorities have not submitted copy of log book of water tanker operational in their project.</p>
iv. The above said Project Proponent is is also contaminating the water by discharging untreated effluents in river SonaDubi.		<p>a. Coal dust layers were observed at some portions on the roads of the project area (see photos 1,42,43). There were chances of those coal dust flowing into the Sonadubi river in case of rainfall since there were no safeguards to stop the flow entering into the river.</p> <p>b. Retaining/ concrete wall was observed to be broken at few places adjacent to the Sonadubi river (see photos 03, 04).</p> <p>c. Coal wastes (rejects) were kept near the washing unit in the project area without any proper safeguards (see photo 05). There were no humps, retaining walls etc. around the coal wastes (rejects) and there were chances of flow of those coal wastes (rejects) into the Sonadubi river (see photo 3,4,5). Bank of Sonadubi river was within 20-21m (approx.) from that coal wastes rejects (see photos 3,4,5,42).</p> <p>d. Conveyor belt system was made over Sonadubi river/conveyor belts over the river were also not covered (see photo 15, 16).</p> <p>e. Large quality of coal was observed on the slope facing the Sonadubi river (see photos 15 & 16,19, 20) i.e. in between KDH railway siding and Sonadubi river. It implies project proponent have not handled coal appropriately and in an environment friendly manner at the railway siding. PP informed that there was a wall between the railway siding slope and Sonadubinala (see photo 16) but at some places the coal spilled over the wall also. There were gully formations within the coal on the slopes (between railway siding and Sonadubi river) and there were chances of coal dust flow in the river</p>

Photo35:Photo of mobile water tanker sprinkling water on road in the north east direction.

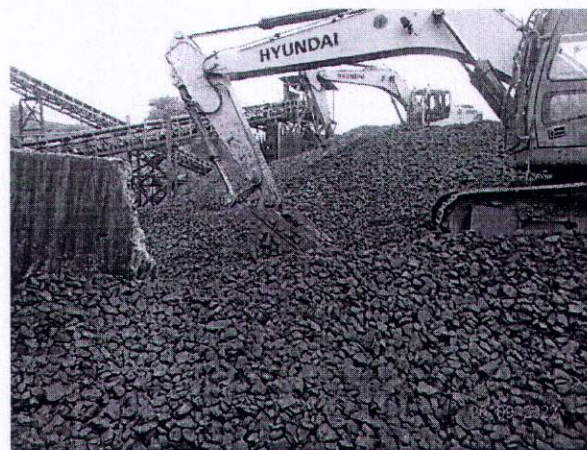
Photo 36: Photo of project boundary wall broken and coal kept beyond boundary in north east direction

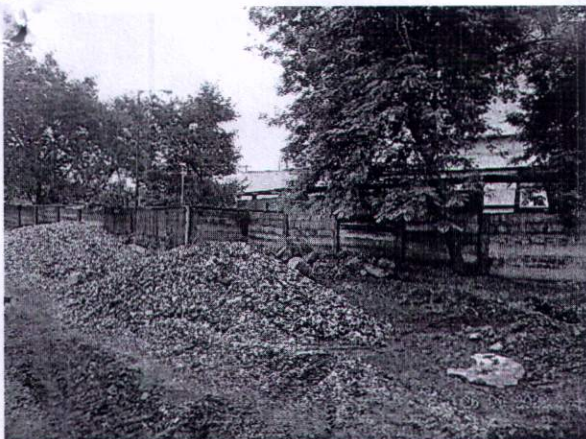
Photo 37: Photo of some plantation at the boundary of project in north east direction

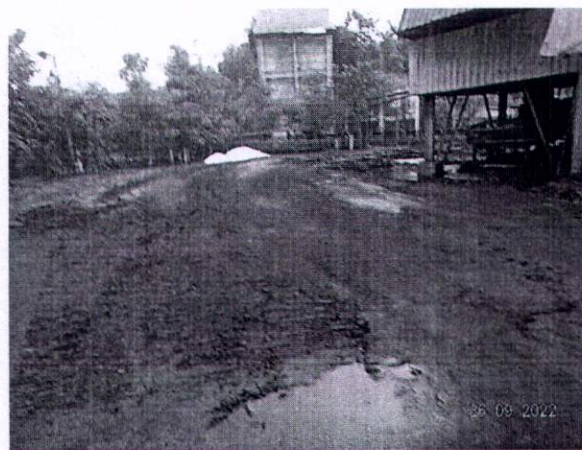
Photo42:Photo of coal dust layers on roads in project area. Sonadubi river is after plantations in left side

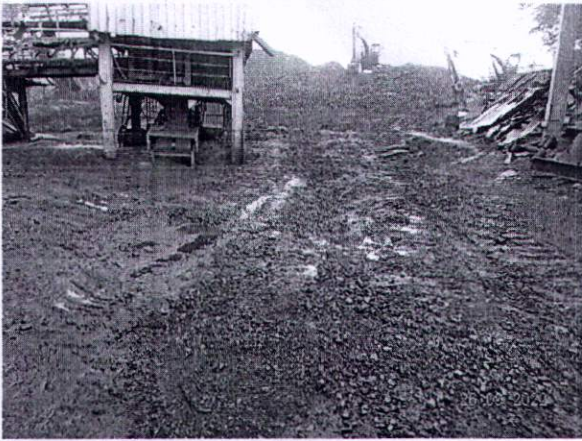
Photo 43: Photo of coal debris on floor area adjacent to coal dumps.
