**Report on Laxmi Taal, Jhansi in compliance of Hon'ble National
Green Tribunal Order in Execution Application No. 38/2022
(in Original Application No. 165/2021) dated 10.10.2023**

**Committee Report on Laxmi Taal, Jhansi in compliance of
Hon'ble National Green Tribunal Order in Execution
Application No. 38/ 2022 IN (Original Application No.
165/2021) dated 10.10.2023**

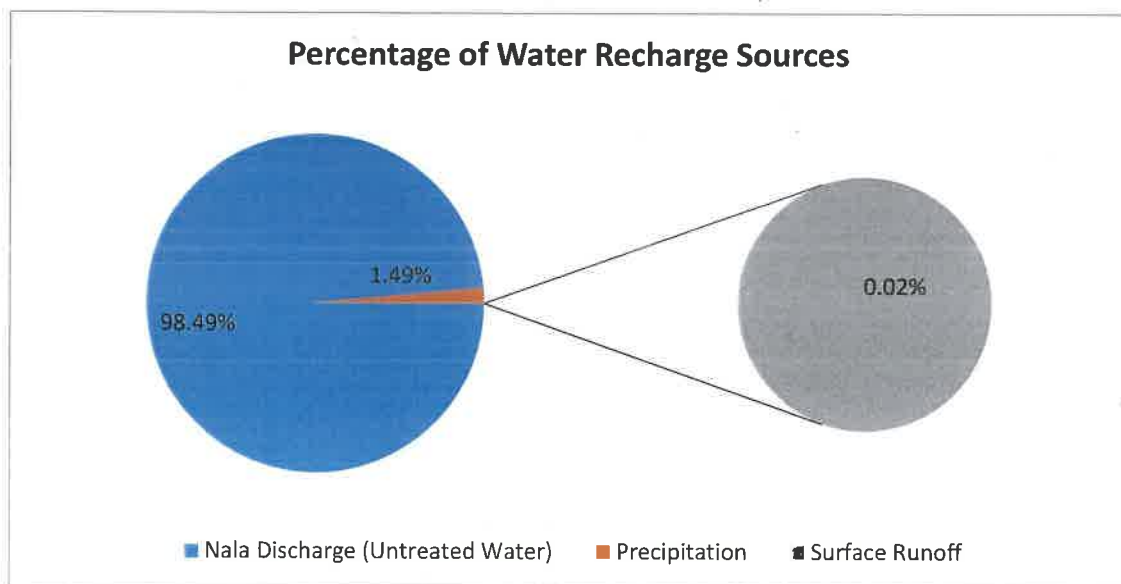
Figure 1: Graph of water recharge source distribution

Originally three water recharge sources were available for Laxmi Taal:

1. **Nala discharge (Untreated water):** The primary source of water flow into Laxmi Taal was water coming out from nearby drains. About 16.528 MLD of untreated water entered the pond, bringing with it pollutants and contaminants from industrial, domestic and other sources.
2. **Precipitation:** Water flows into the pond through rainfall. Due to rainfall in 2007, about 0.25 MLD of water was accumulated in Laxmi Taal. Although this water is naturally occurring, it may carry atmospheric pollutants, emphasizing the importance of monitoring its quality.
3. **Surface runoff:** A small but notable contribution comes from surface runoff, with approximately 0.0027 MLD of water entering the pond in 2007. This runoff, originating from impervious surfaces, carries pollutants and increases overall water volume.

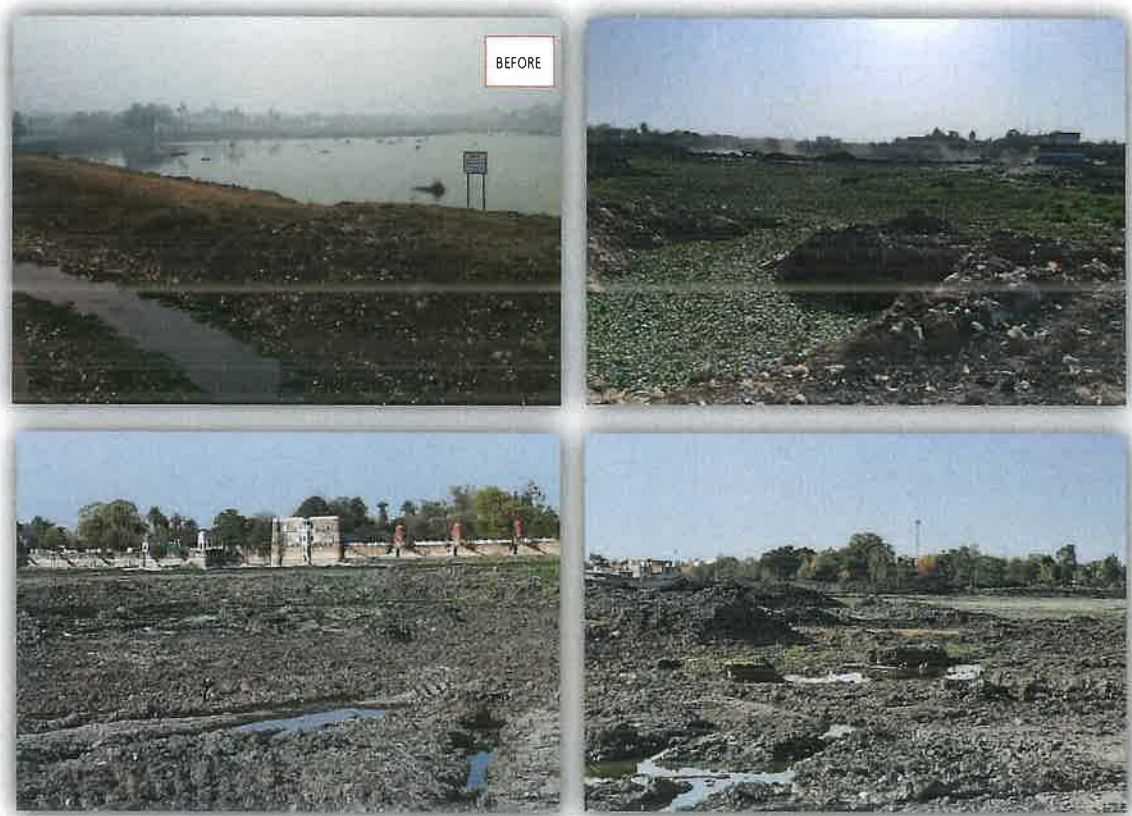
Figure 2: Photographs of Laxmi Taal before restoration.

Weeds were well developed and caused eutrophication in Laxmi Taal (Sharma & Singh, 2016). Laxmi Taal was home to a variety of common biological growths, such as *Cyperus rotundus*, *Cyperus alopecuroides*, *Ipomea aquatica* (water spinach), *Azola pinnata*, *Typha angustifolia* (cattail), *Echhornia crassipes* (water hyacinth), and *Spirodela* spp. (duck weed). Because Narayan Bagh is located on the other side of Laxmi Taal, this location is known as a bird watching spot. In this Taal and surrounding area, it was common to see native and migratory birds (Panwar, 2008). Due to pollution of Laxmi Taal, a decline in the number of birds has been observed here.

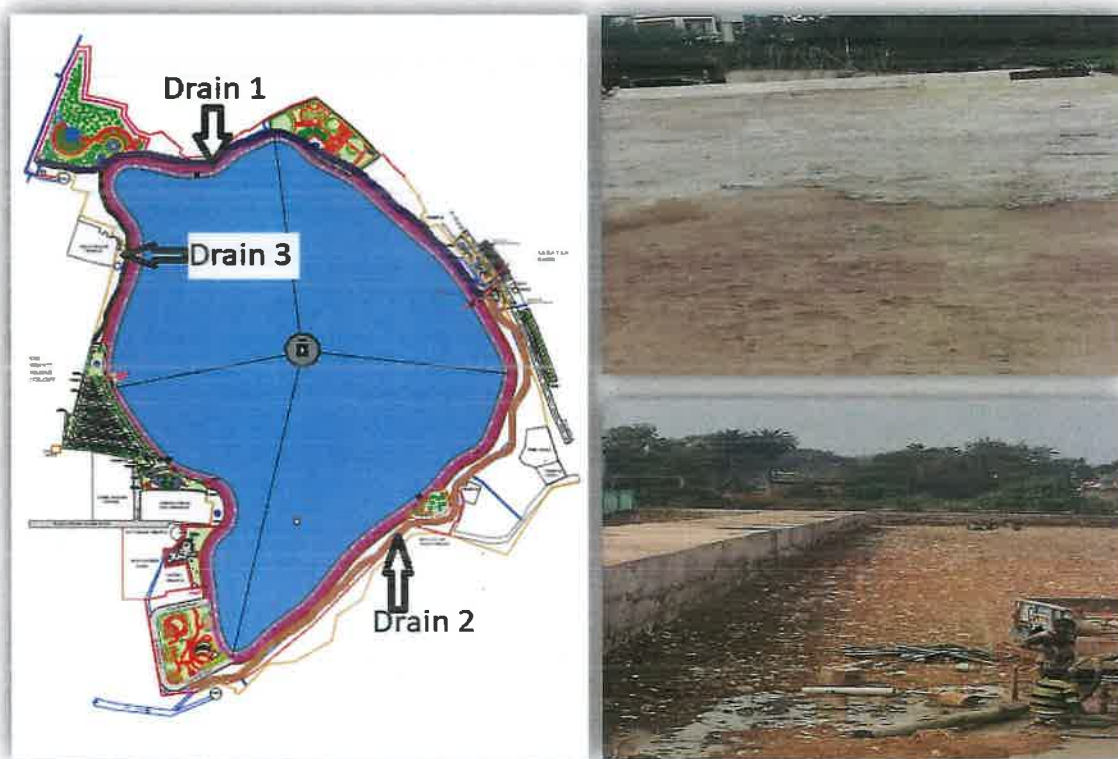
Figure 3: Drains around the Laxmi Taal for collecting runoff water from catchment area and connecting drains with SPS1 and SPS2

- Tapped all Nalas:** As per experts' opinion, Jhansi Smart City tapped all the seven drains and connected them to the STP plant for treatment. After treatment, this treated water is released into Laxmi Taal. This approach is a major step in a suitable way to reduce the direct untreated water discharge into the pond from Kuberau Nala, Kasai Mandi Nala, Laxmigate Nala, Joshiyana Nala, Banglaghat Nala, Dhimaryana Nala, and Om Shanti Nagar Nala. The DPR shows initiative in tackling the main cause of pollution influencing the pond's water quality by directing these nalas via the sewage treatment plant. In accordance with best practices in wastewater management, these nalas have been redirected for treatment, guaranteeing that the water discharged into Laxmi Taal satisfies acceptable environmental criteria.

- **Tapped surface runoff:** The Jhansi Smart City shows a commitment to reducing any pollution concerns connected with untreated water by capturing and treating runoff before it enters the water body. This calculated detour is in line with best practices for managing urban water resources and demonstrates an eco-friendly strategy aimed at preserving the habitat and ecosystem of the pond without change in **catchment area** of Laxmi Taal.

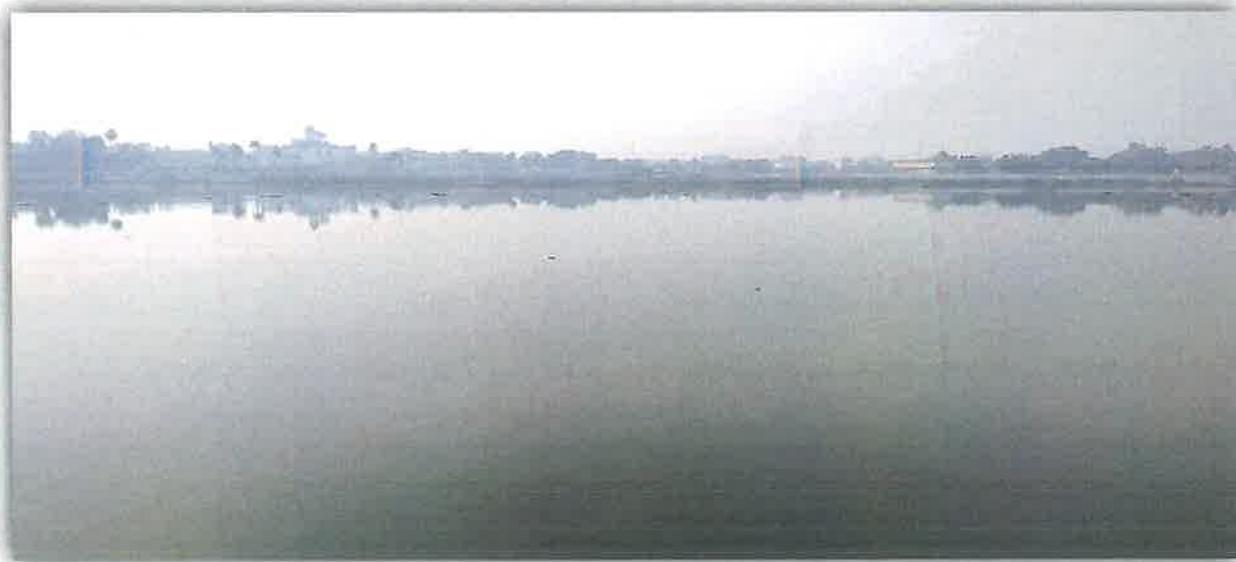
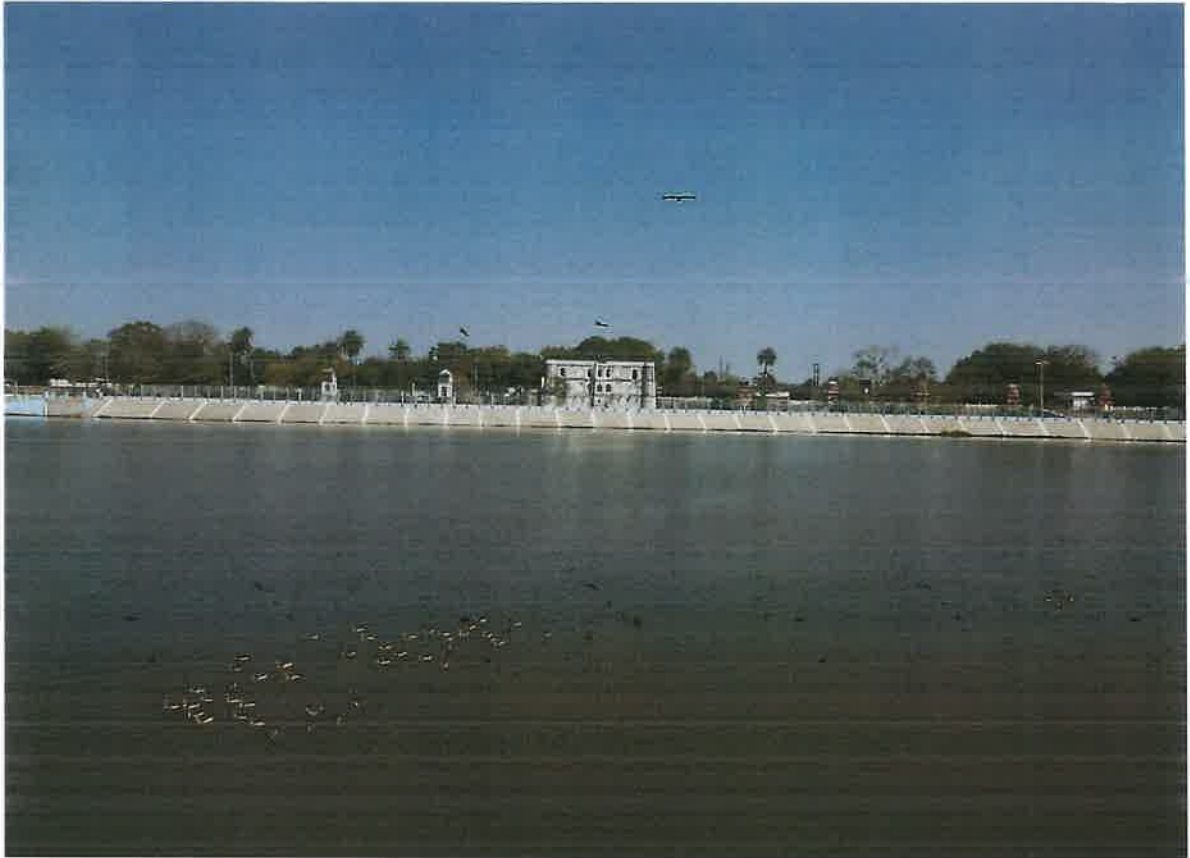
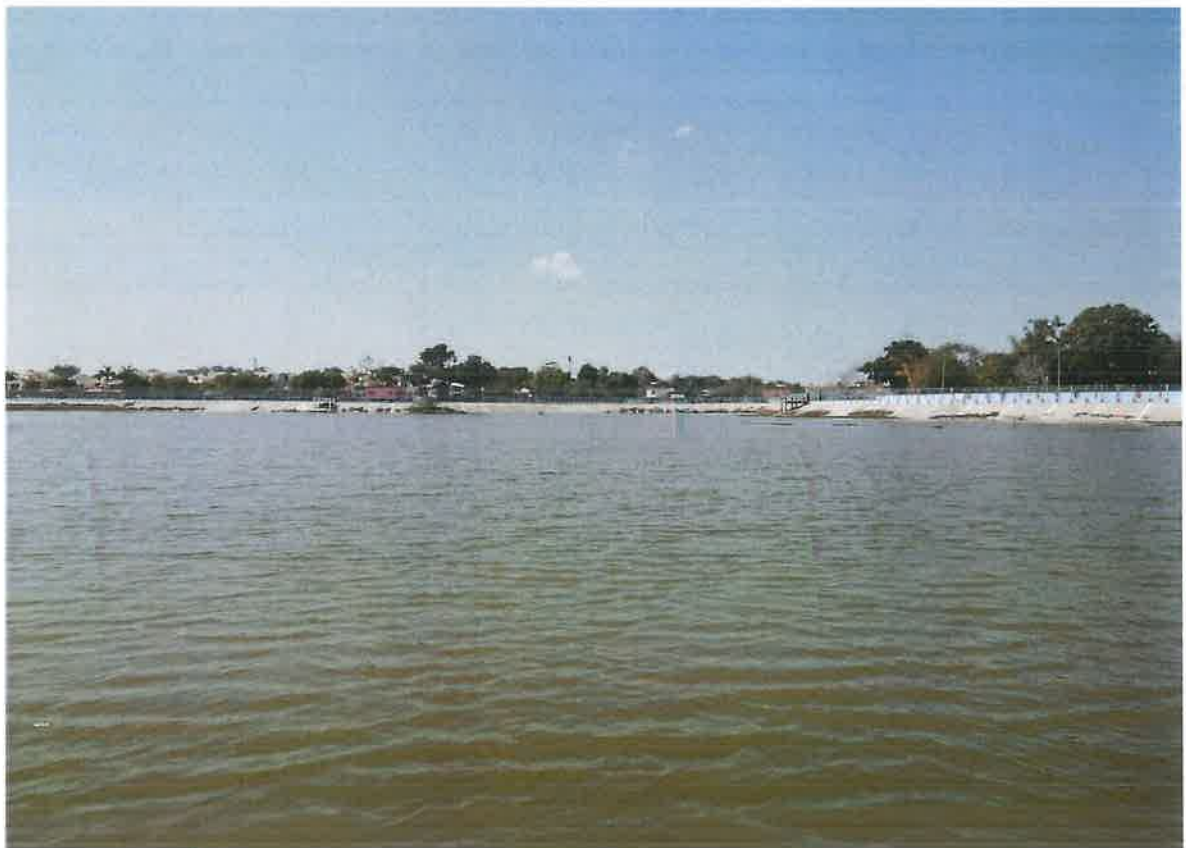
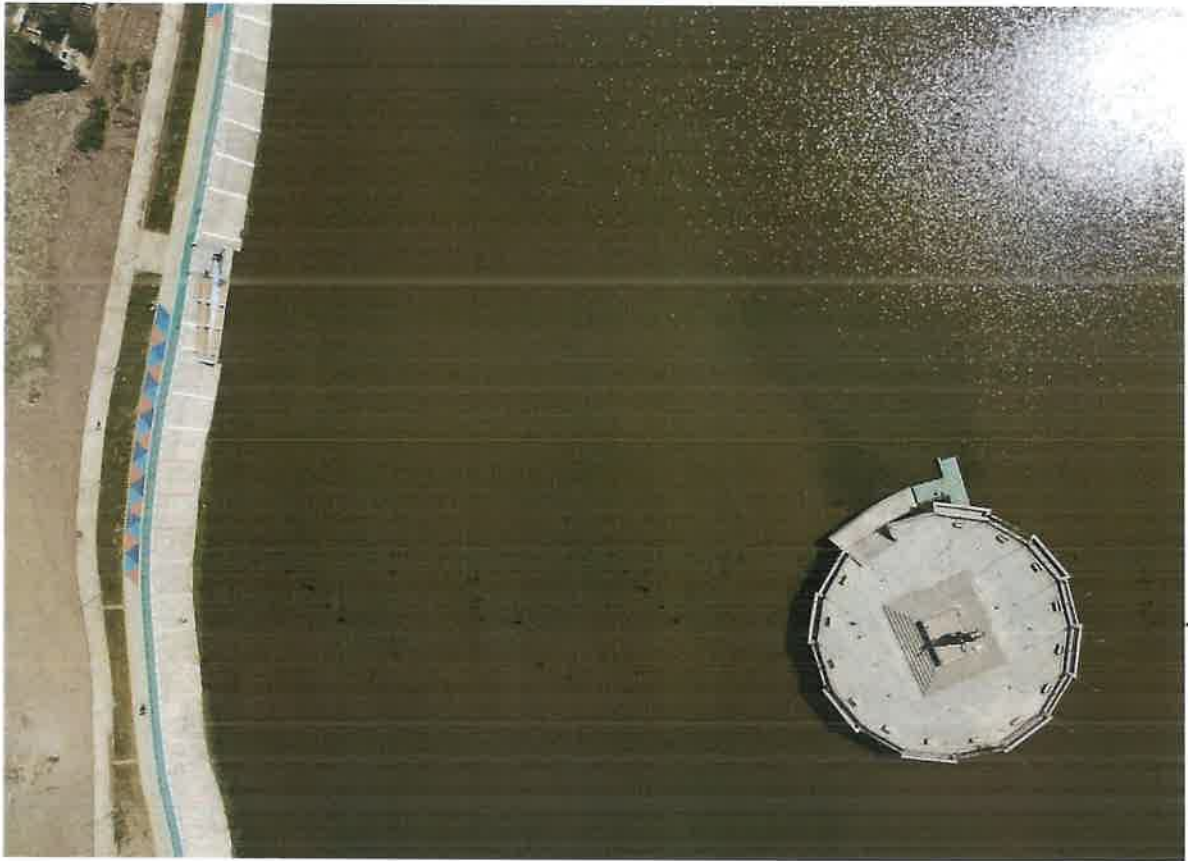
Figure 4: Current view of Laxmi Taal

There has been no disturbance to the catchment area and even after completion of the project the catchment area is 2370 hectares. During the entire project, 5738.26 m³ of silt has been cleaned, increasing the storage capacity of Laxmi Taal to 1727000 m³. Various physicochemical parameters were analysed to determine the water quality status of Laxmi Taal. The results of physicochemical properties are shown in the *Table 2*. All the water samples were analysed at the

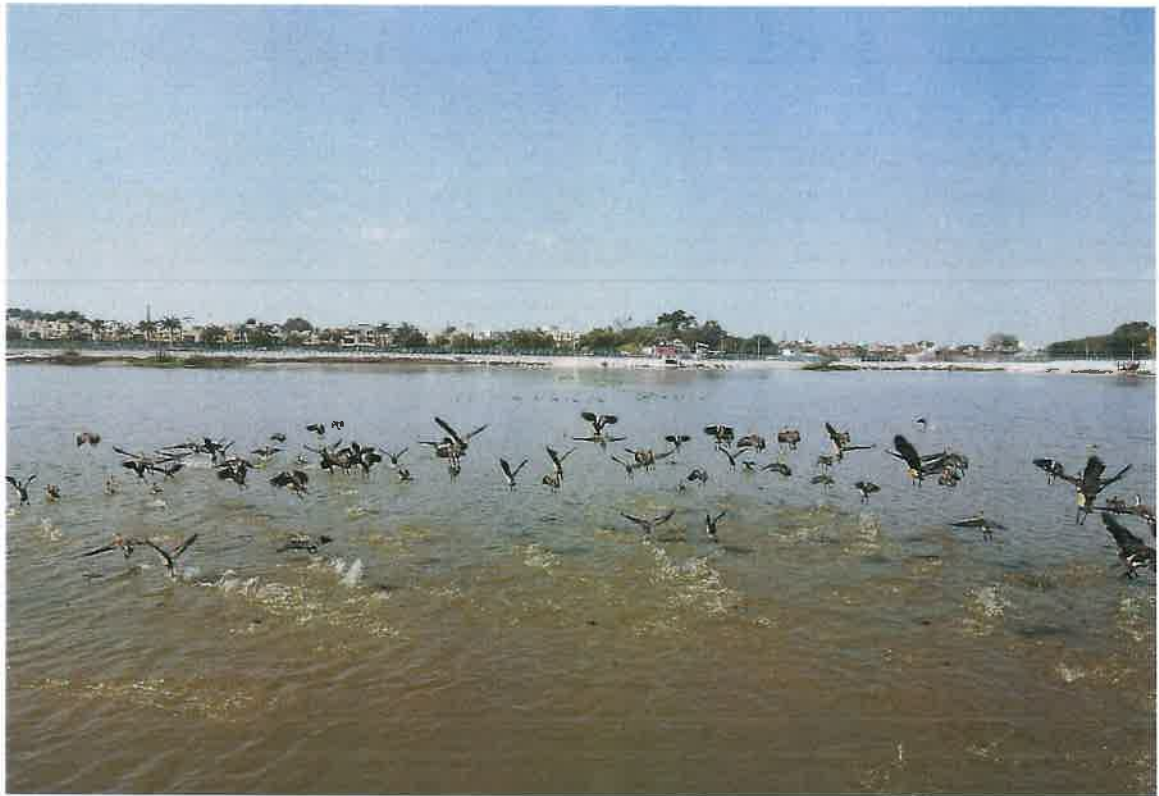
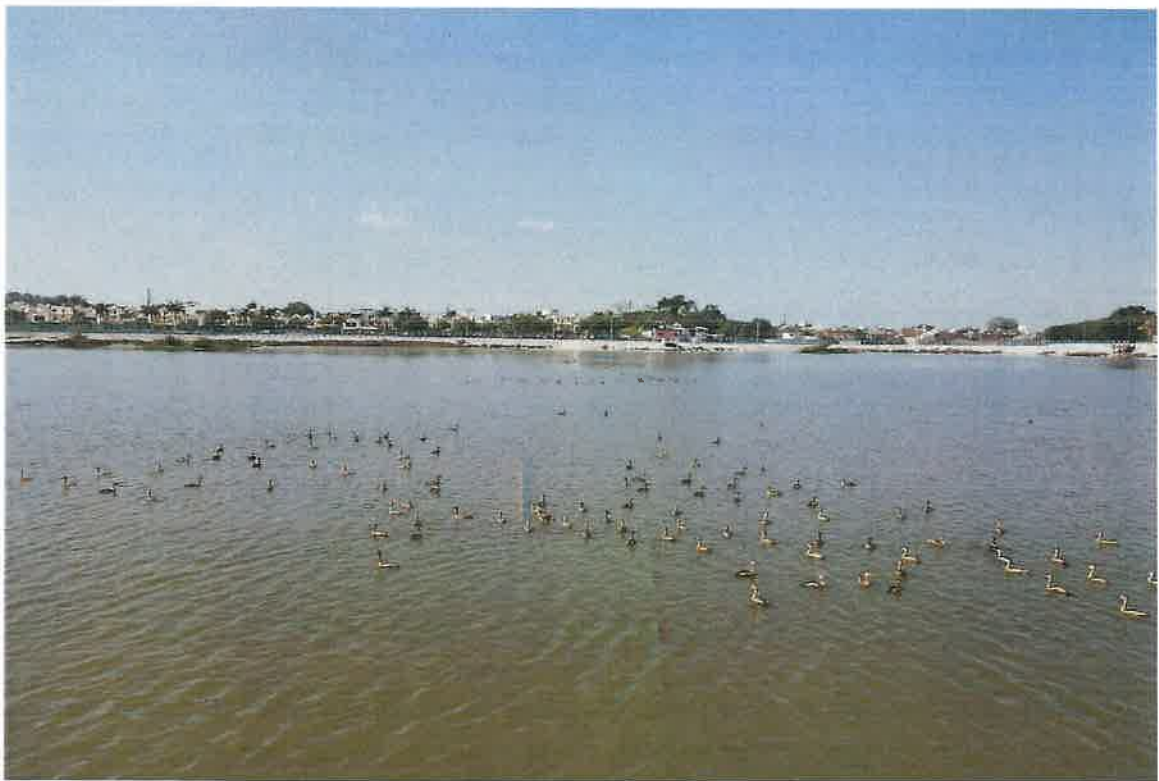
Figure 5: Presence of Migratory Birds at Laxmi Taal

Furthermore, Laxmi Taal's biodiversity has benefited from the decline in pollution levels. Due to the contaminated water, migratory birds and native species that had previously vanished have begun to return in search of food. The return of avian life to the area is a strong sign of the area's ecological recovery and shows how well the restoration efforts have done in making Laxmi Taal a more pleasant and sustainable environment for the flora and wildlife.

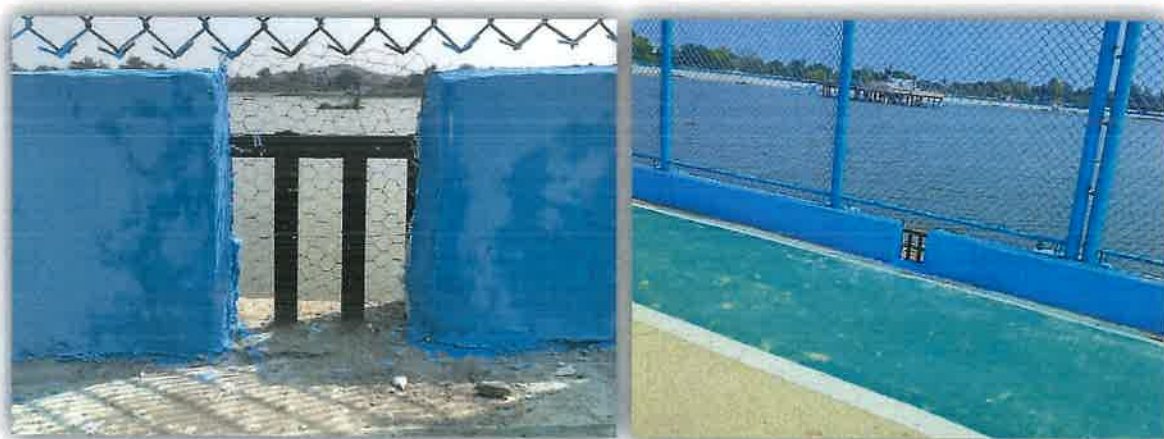
Figure 6: Fencing and 300mm x 230 mm hole in the wall

In order to protect Laxmi Taal from the entry of undesired pollutants, the decision was made to construct fencing and drill holes in the wall surrounding the pond. By serving as a physical barrier, the fencing restricts people from throwing trash and other contaminants into the pond. Though, sloping pattern has been made in such a way that the surface water first flows down to the drain and after filtration it is discharged in to the pond. However, additional holes measuring 300 mm x 230 mm, made every 40 metres have been made so that water flowing from walking track portion may directly go to Laxmi Taal through controlled wired mesh. The project intends to maintain the pond's water quality and ecological integrity by combining the protective barrier of the fencing with well-placed holes, thus aiding in the sustainable and healthful management of Laxmi Taal.

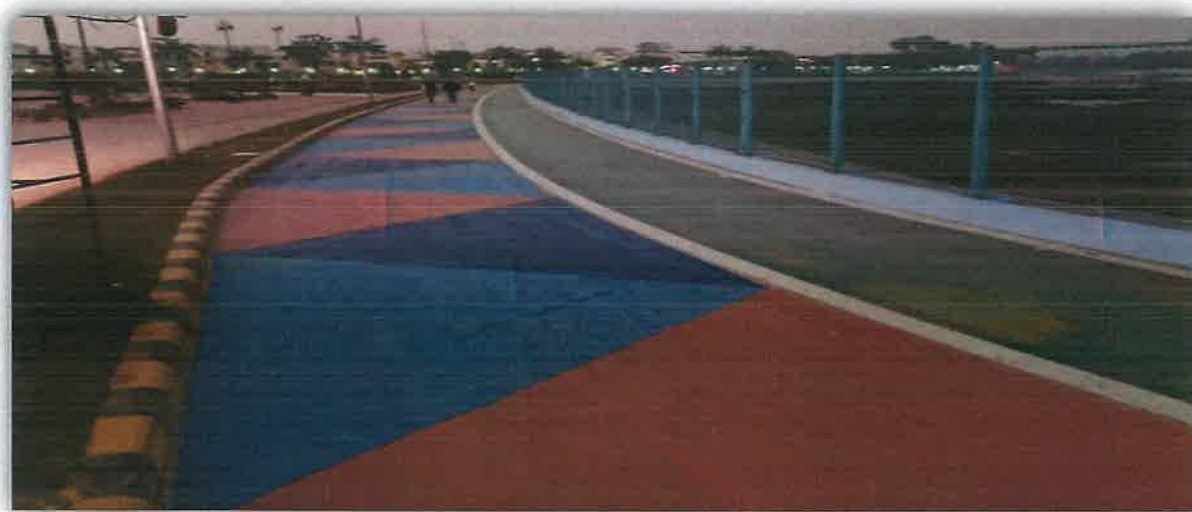
Figure 7: Photograph of the pathway at Laxmi Taal

Looking at the data obtained from various studies as shown above, the surface runoff water constitutes only 0.02% of the total water recharge of Laxmi Taal. However, direct flow of surface runoff water in Laxmi Taal is susceptible to various contaminations and pollutants causing eutrophication and pollution of the water body. Expert studies have highlighted the need of tapping this surface runoff and treating it before its discharge in the water body. Therefore, an elevated boundary wall could prevent the direct inflow of surface water into the water body. Further, there is drainage system built around the periphery of Laxmi Taal and sloping pattern has been designed to collect water inflow around the periphery directly in the drainage system followed by treatment of collected water via STP before discharge. Also, there is no impact in the catchment area of Laxmi Taal. Moreover, this lake is now located in the posh area of the city where land cost is very high. Therefore, there is a very high probability of encroachment in the long run. Construction of the boundary wall will also prevent encroachment of this prime land.

Further, pathways built around the ponds allow scope of community participation and developing it as a tourism spot. Since, the surface runoff is already tapped through drainage system without influencing catchment area; this pathway doesn't have any negative impact on the water body. Further, this recreational area will help public to take a walk around and appreciate the beauty of this lake and its eco-system. This community participation will increase the awareness about nature and its perseverance. Hence, after looking this entire project holistically, both boundary wall and pathways are in line with the recommendations of various experts in their studies and in the long-term sustainability of this project.

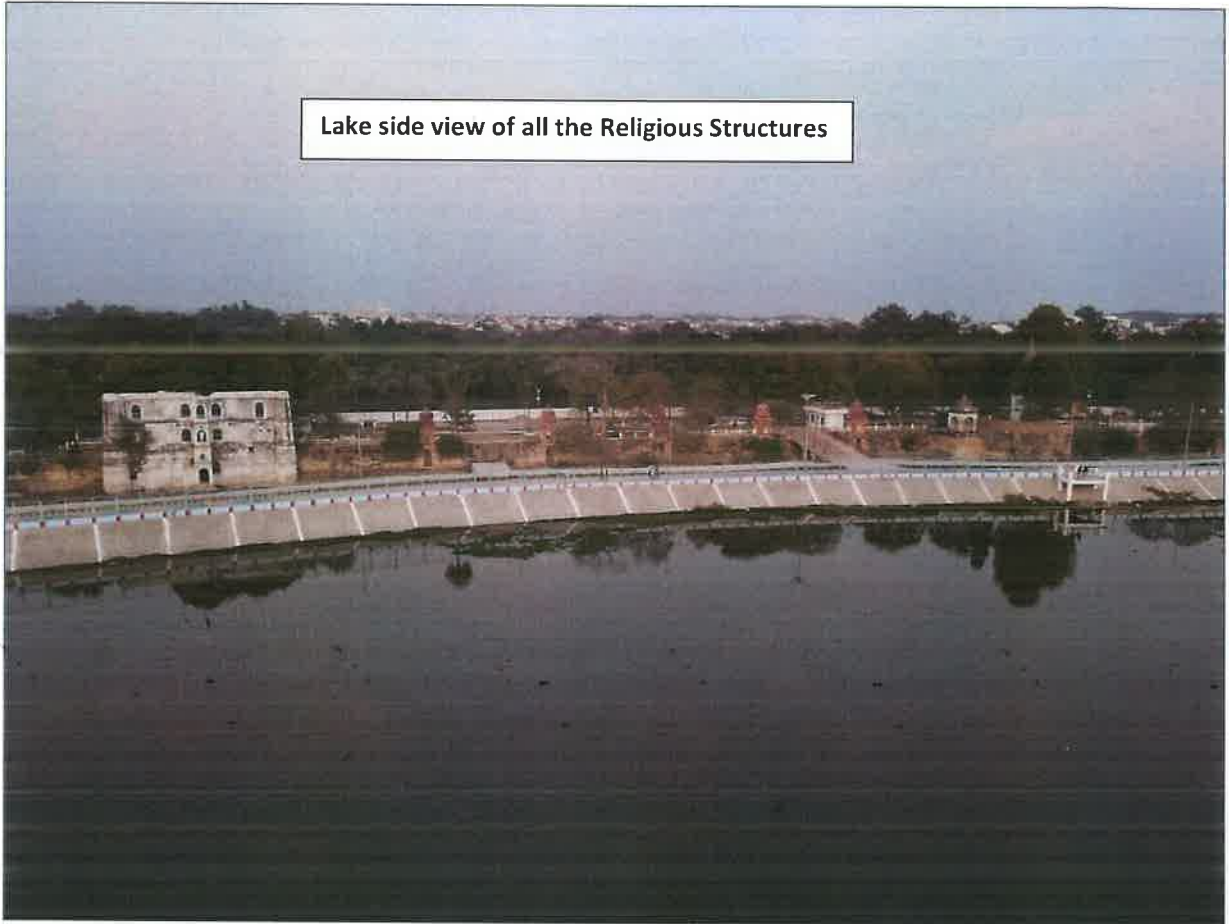
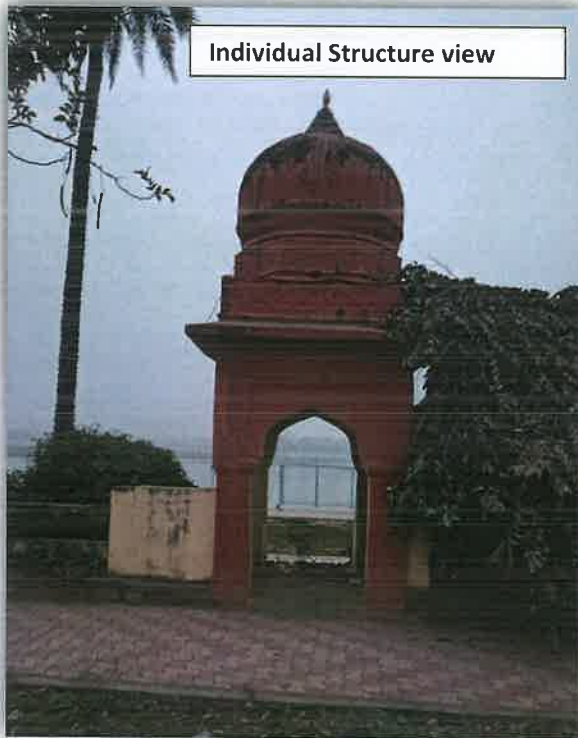
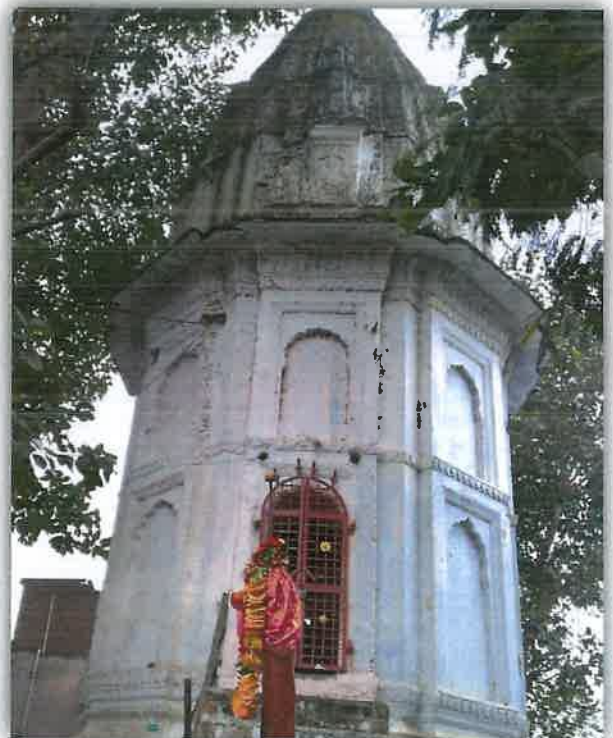
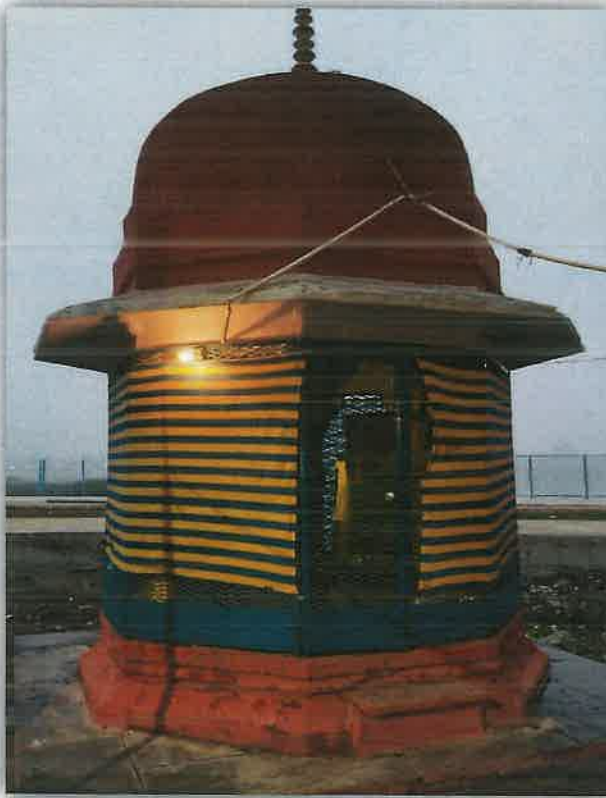
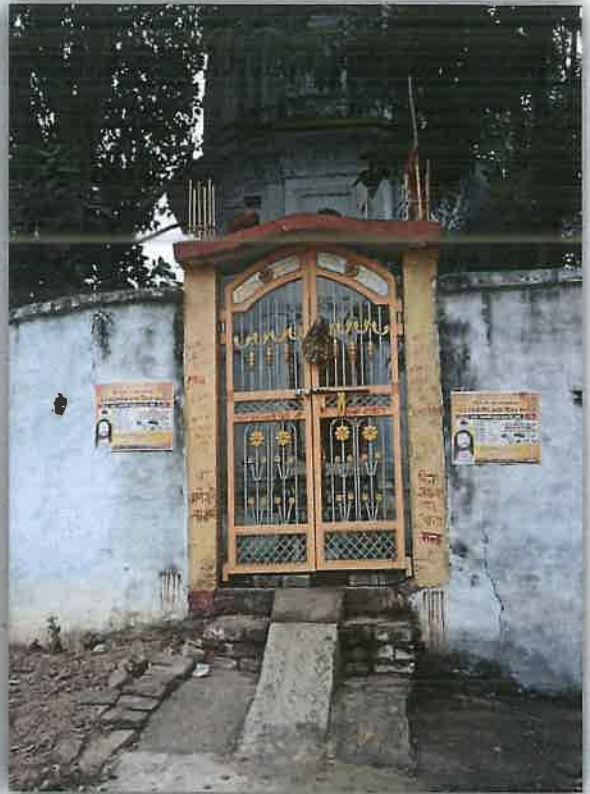
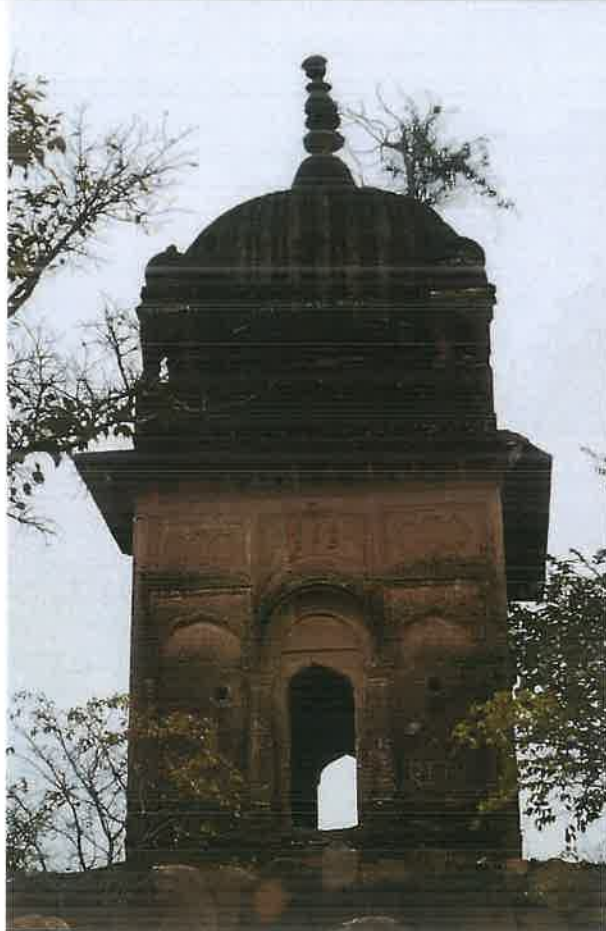
Figure 8: Photographs of religious and historical monuments around Laxmi Taal

As per various studies quoted above, interaction with local people and observation of constructed religious structures it appears that these religious structures have co-existed along with Laxmi Taal for centuries together. Further it is also highlighted that out of approximate 33 ha area of Laxmi Taal, these structures have been built on a mere 350 m² (0.035 ha approximate). Further, it would attract crowd which will indirectly promote community participation. Also, no negative ecological impacts were observed because of these structures on Laxmi Taal.
