**NEWS ITEM APPEARED IN greaterkashmir.com Dated  
29.04.2024 "Land sinking: A new environmental challenge in J  
& K"**

**RESPONSE AFFIDAVIT ON BEHALF OF THE  
RESPONDENT NO. 4**

**Annexure R4-A**

**News item titled "Land Sinking: A new environmental challenge in J&K" appearing in greaterkashmir.com dated 29.04.2024.**

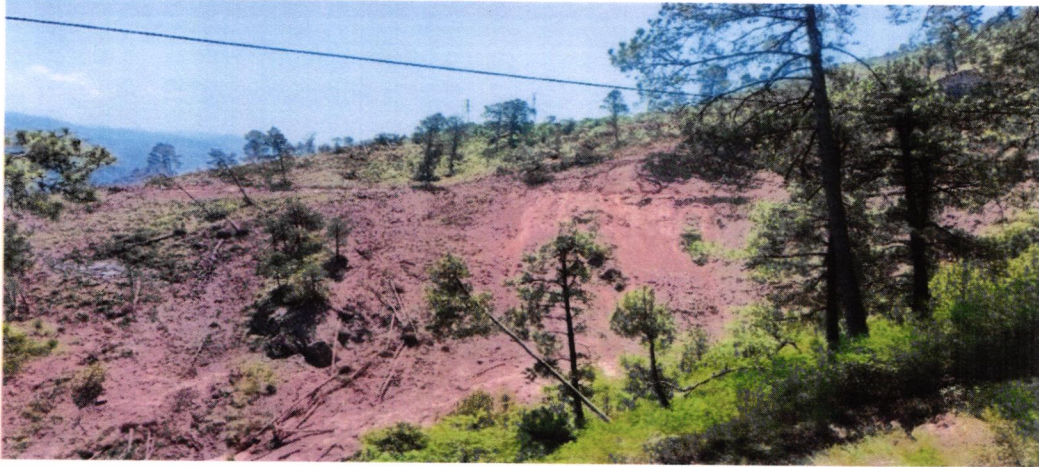
Fig. 4. The landslide occurred in loose and unconsolidated sediments of mudstone intermixed with clasts of broken sub-mature boulders of sandstone at the altitude of ~1165m asl.

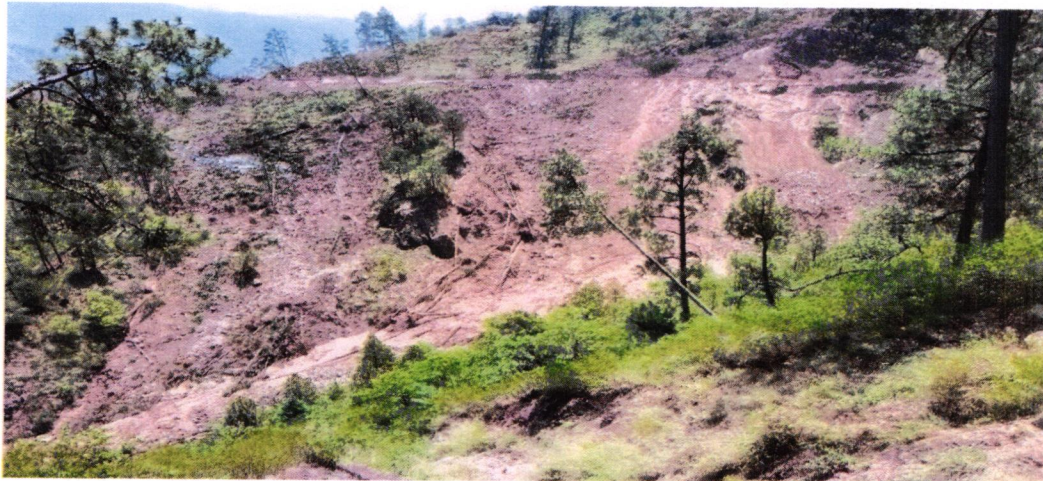
Fig. 5. Illustrating large sliding zone comprised of loose debris of mudstone and sandstone.

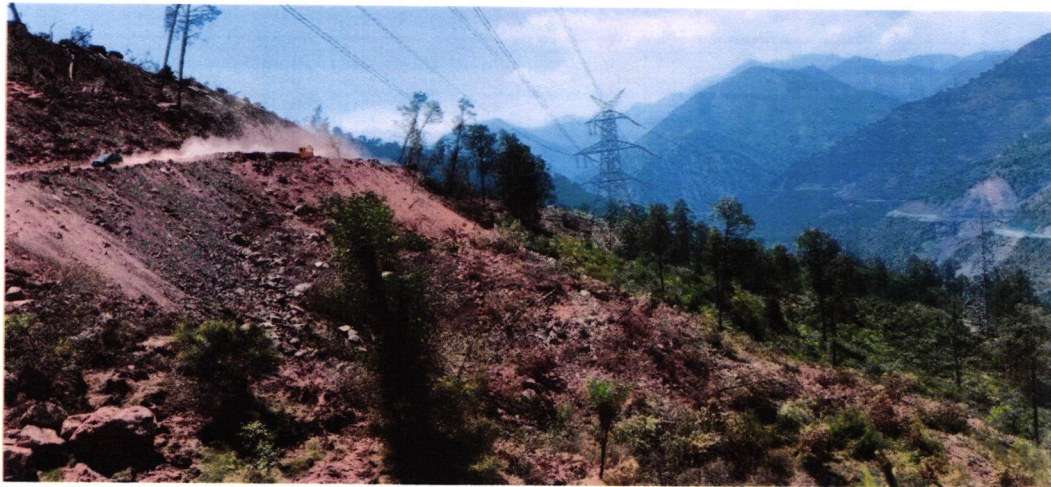
Fig. 7. Illustrating landslide affected slope; the displaced debris composed of clasts of mudstone, siltstone, and boulders of sandstone.
