BEFORE THE NATIONAL GREEN TRIBUNAL PRINCIPAL BENCH, NEW DELHI Original Application No. 481/2024

News item titled "*Major fire erupts at Delhi's Ghazipur landfill site smoke engulfs region*" appearing in the Hindustan Times dated 21.04.2024.

REPORT OF THE COURT COMMMISSIONER IN COMPLIANCE OF ORDER DATED 07.03.2025

OBSERVATIONS REGARDING THE LANDFILL

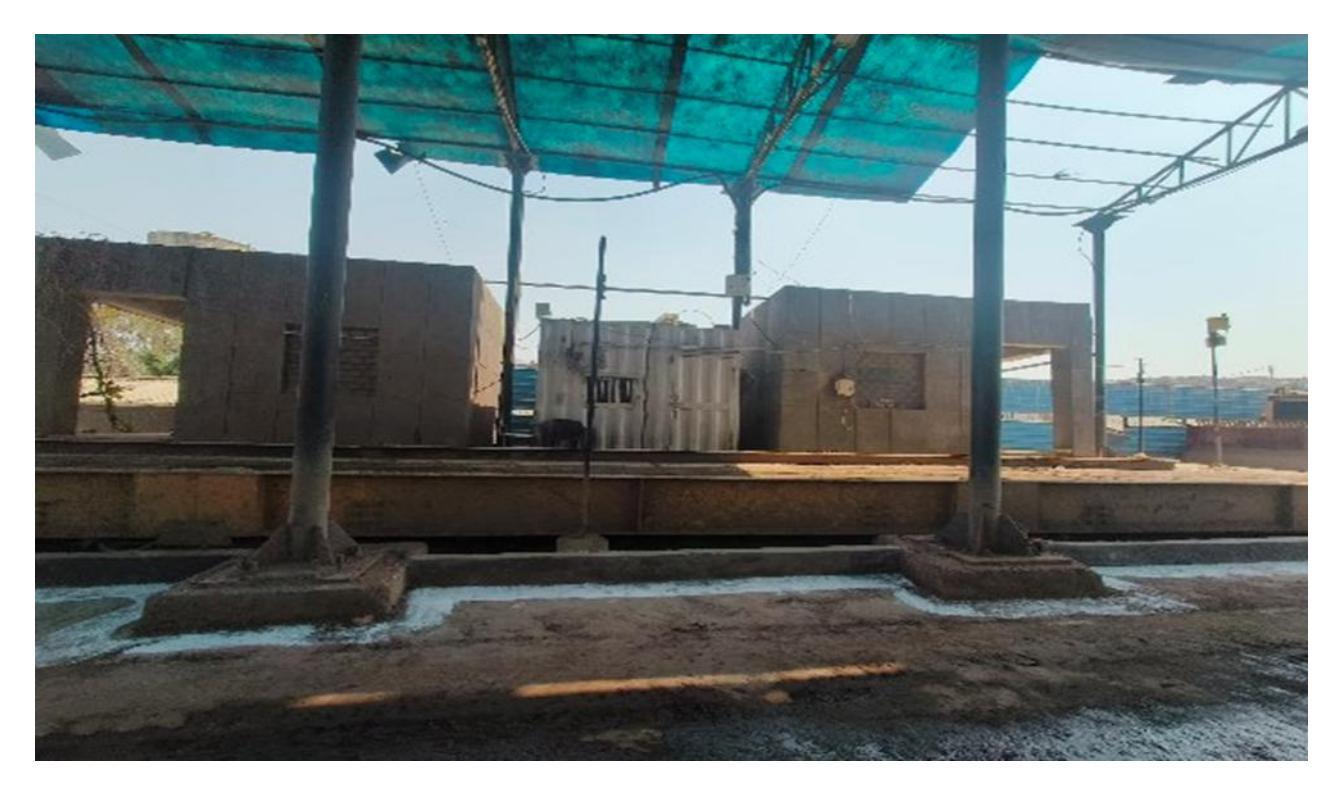
1. Weigh Bridge at the Entrance

- 1. All the unsegregated waste is brought by MCD trucks from parts of East Delhi
- 2. The trucks are weighed at the bridge to ascertain quantity of waste per day.
- 3. Waste received was around 2361.45 TPD (on inquiry the officials reported that Okhla Plant is under some maintenance so all fresh waste is being dumped at Ghazipur, even the part that is sent to Okhla).

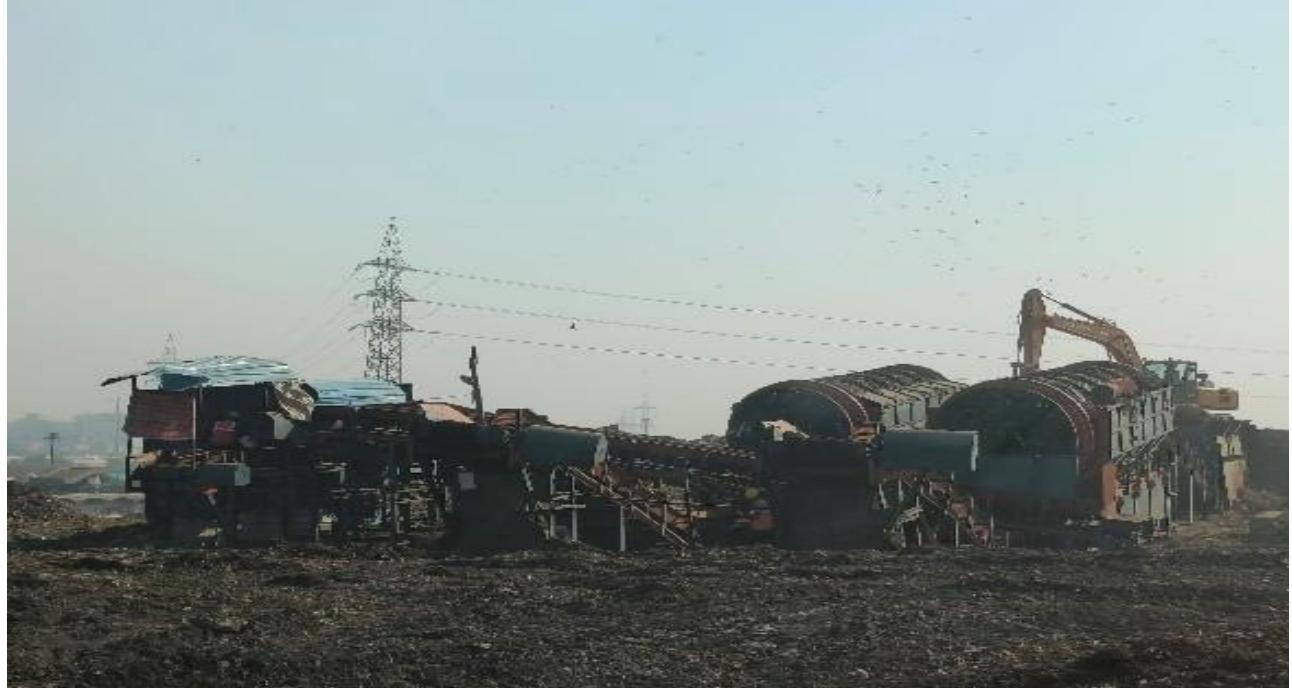
2. Trommel near the SLF entry

Waste processing through biomining was going on at 3 different location at the landfill site with the help of trommels and human labour.

These two trommels were seen near the entry of the SLF office (opposite fish mandi)

**It is to be noted that this is the same area claimed to have been rememdiated and reclaimed from the landfill.

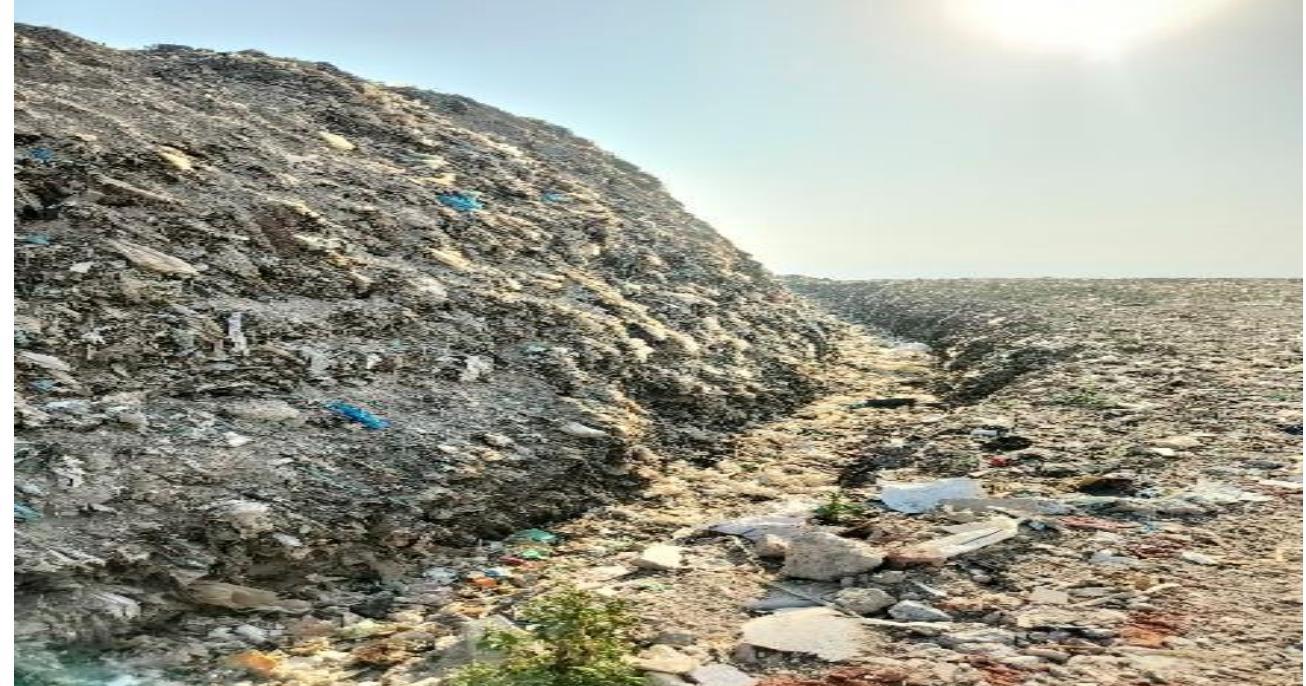
3. Garland drain for leachate

Such drains have been created to create a passage for leachate, especially during high flow seasons like monsoon and alter diverted to the tank.

It was informed by the MCD officials that the collected leachate is being sent to Okhla plant for treatment and some is also used for sprinkling on the landfill.

However, it is pertinent to note that the leachate drain was partially tapped.

Complete Leachate Management System – Implement a robust leachate collection, treatment, and recycling system to ensure zero contamination of surrounding land and water bodies.

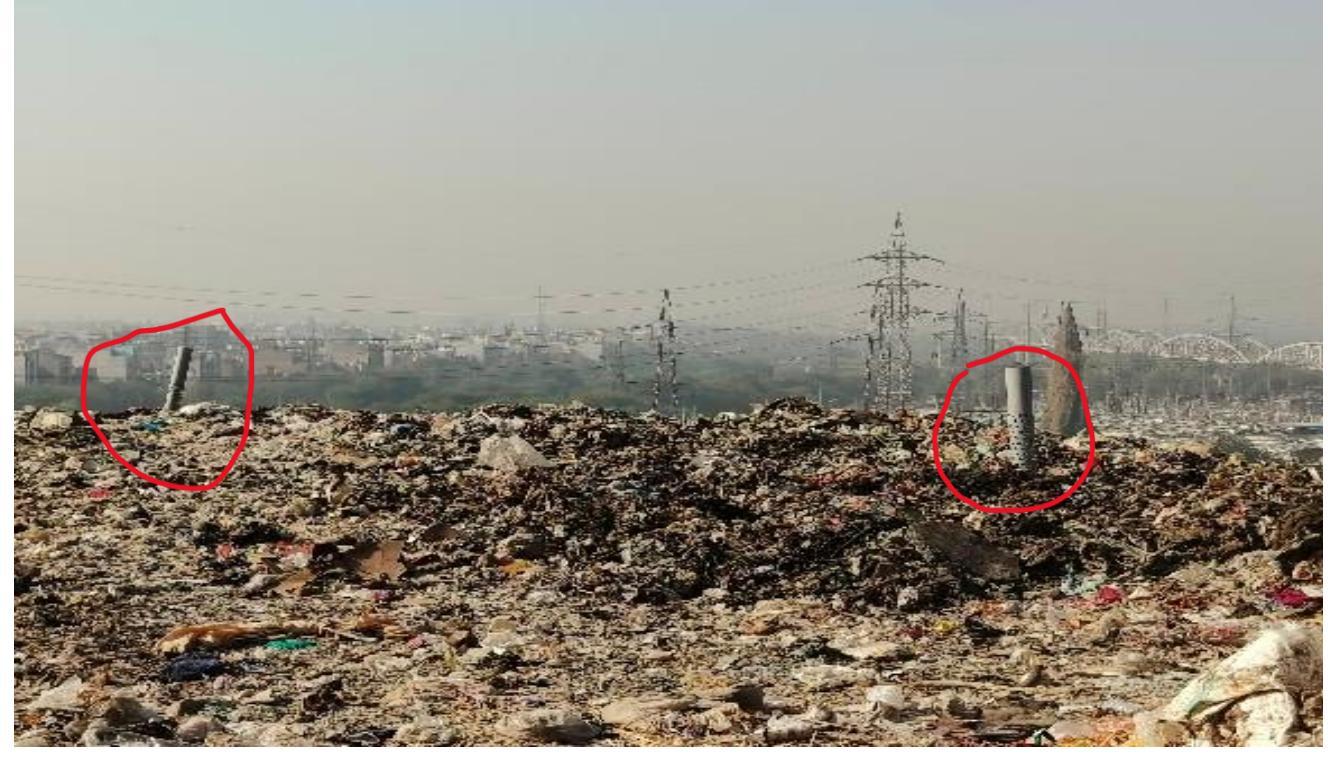
5. Vertical Methane vents

Vertical methane vents could be seen at few places at the landfill site. It is not collected but simply let out in the atmosphere.

- 9. Methane Capture and Energy Utilization Establish an efficient methane gas extraction, storage, and utilization system to generate electricity and reduce greenhouse gas emissions.
 (Required timeline: 7 months)
- **10. Regular Groundwater Quality Monitoring** Conduct periodic groundwater testing around landfill sites to detect and mitigate potential contamination risks.

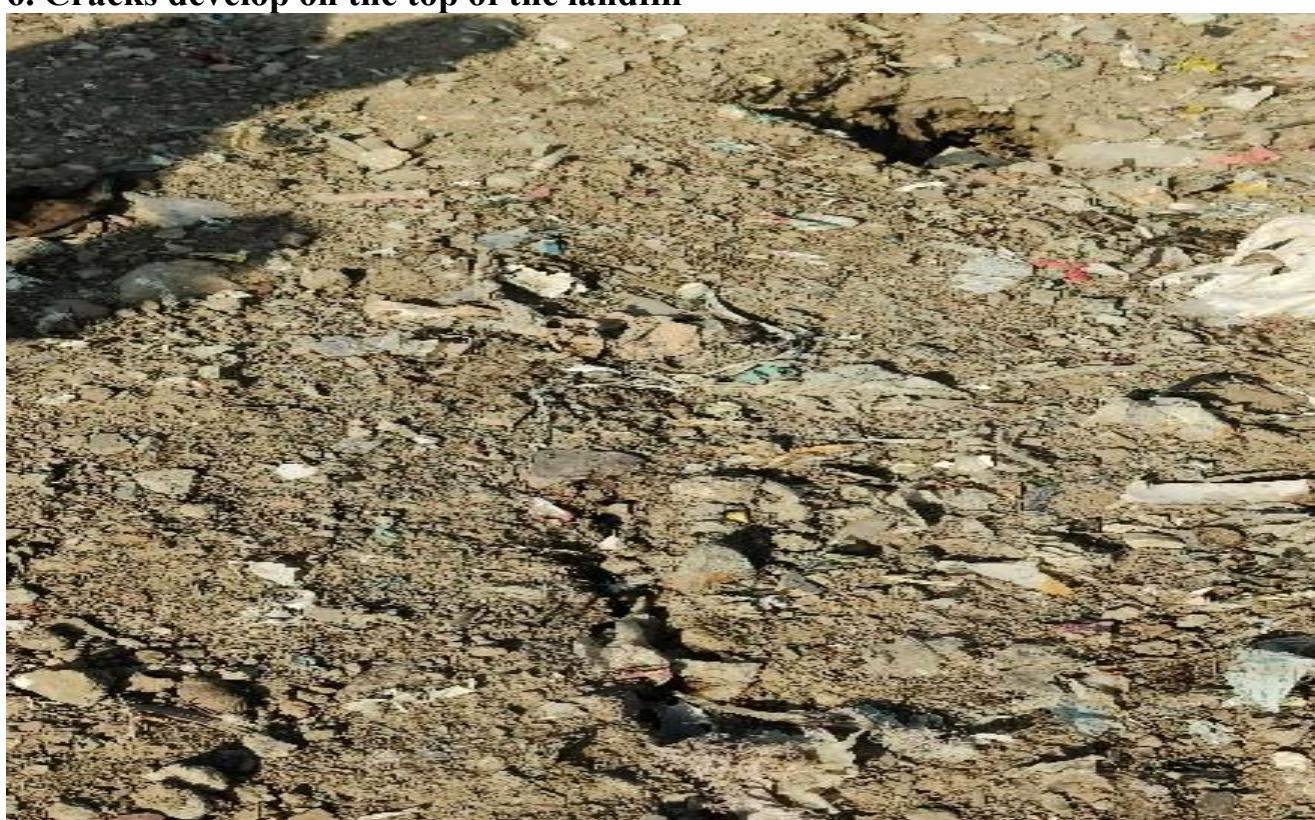
6. Cracks develop on the top of the landfill

Cracks have developed on top of the landfill site (facing the fish mandi)

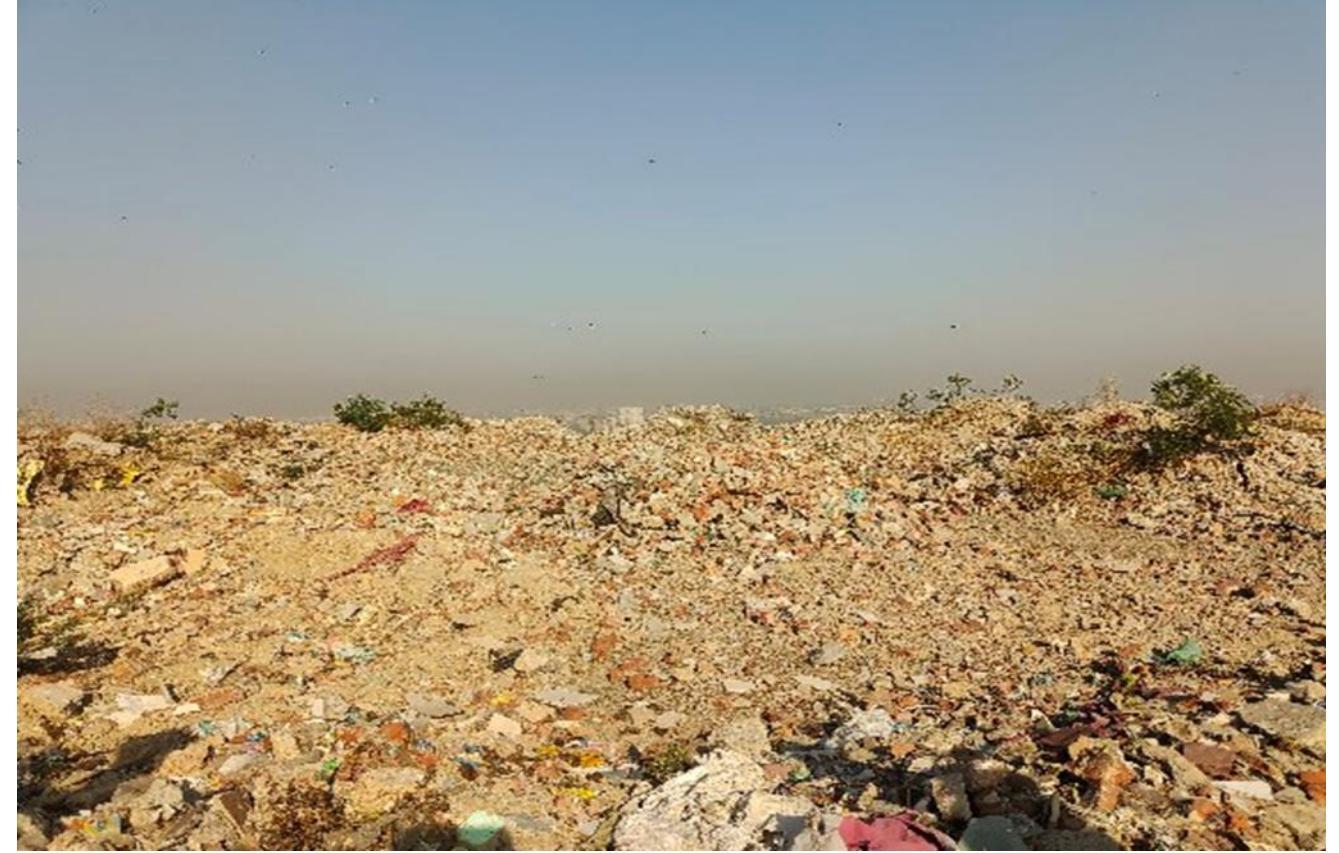
7. C& D Waste Dumped on top

Construction and demolition waste was found dumped at various places on the landfill site. It was informed that C& D waste is kept to douse off fire.

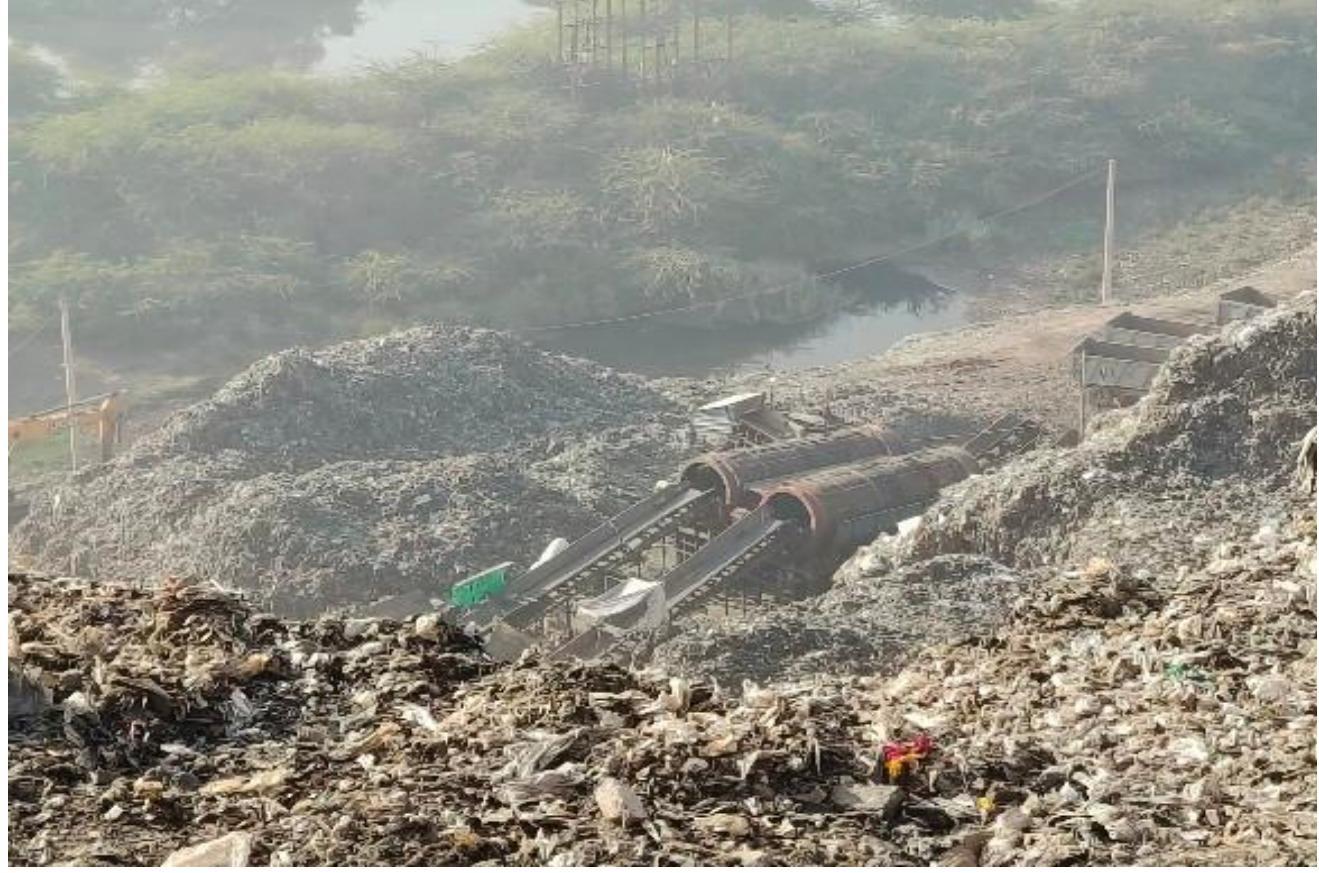
8. Tanker sprinkling water to mitigate dust

Few tankers were noticed sprinkling water on the landfill pathways to eliminate dust pollution

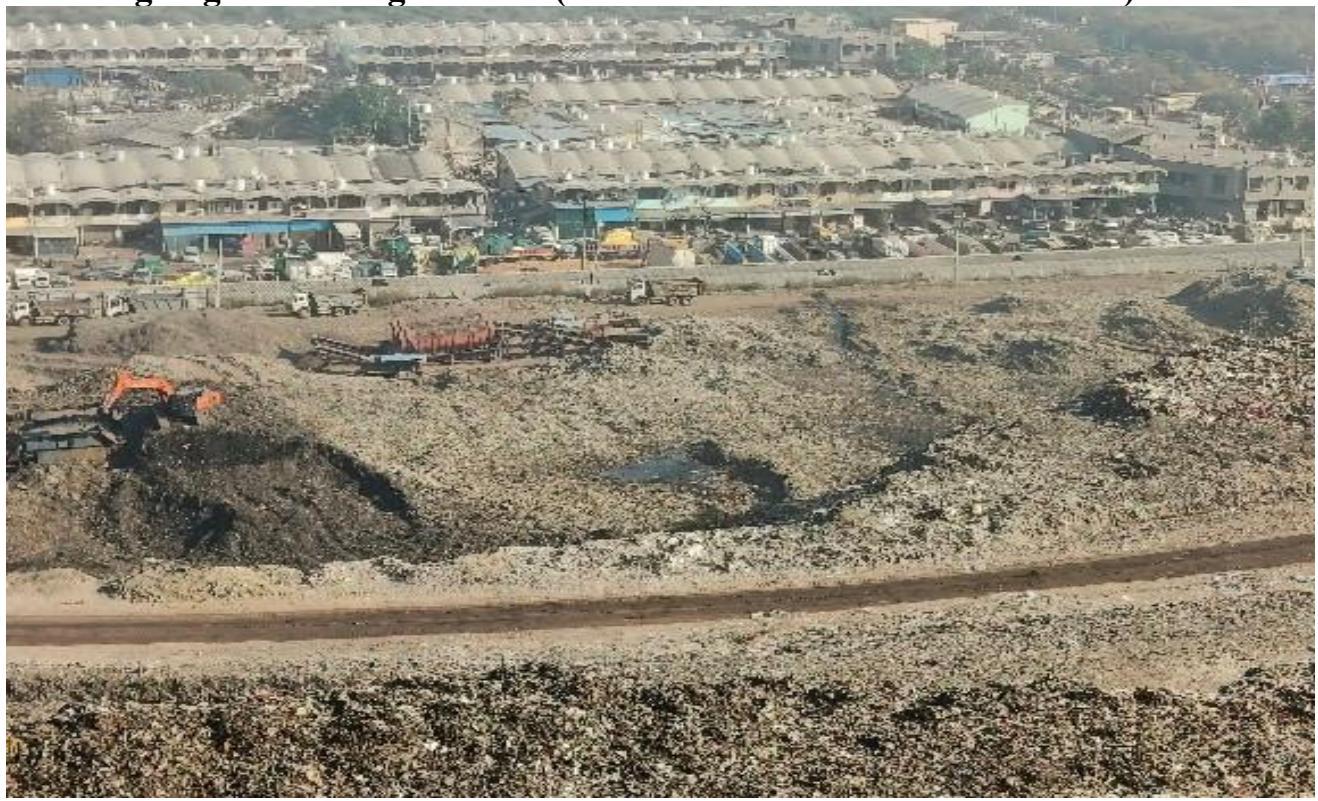
9. Trommel towards canal/ drain 1

Two trommels were in operation on the canal side of the site, where no boundary wall was present.

Secure Perimeter and Controlled Access – Strengthen boundary walls around landfill sites and install security checkpoints with surveillance to prevent unauthorized dumping and encroachment.

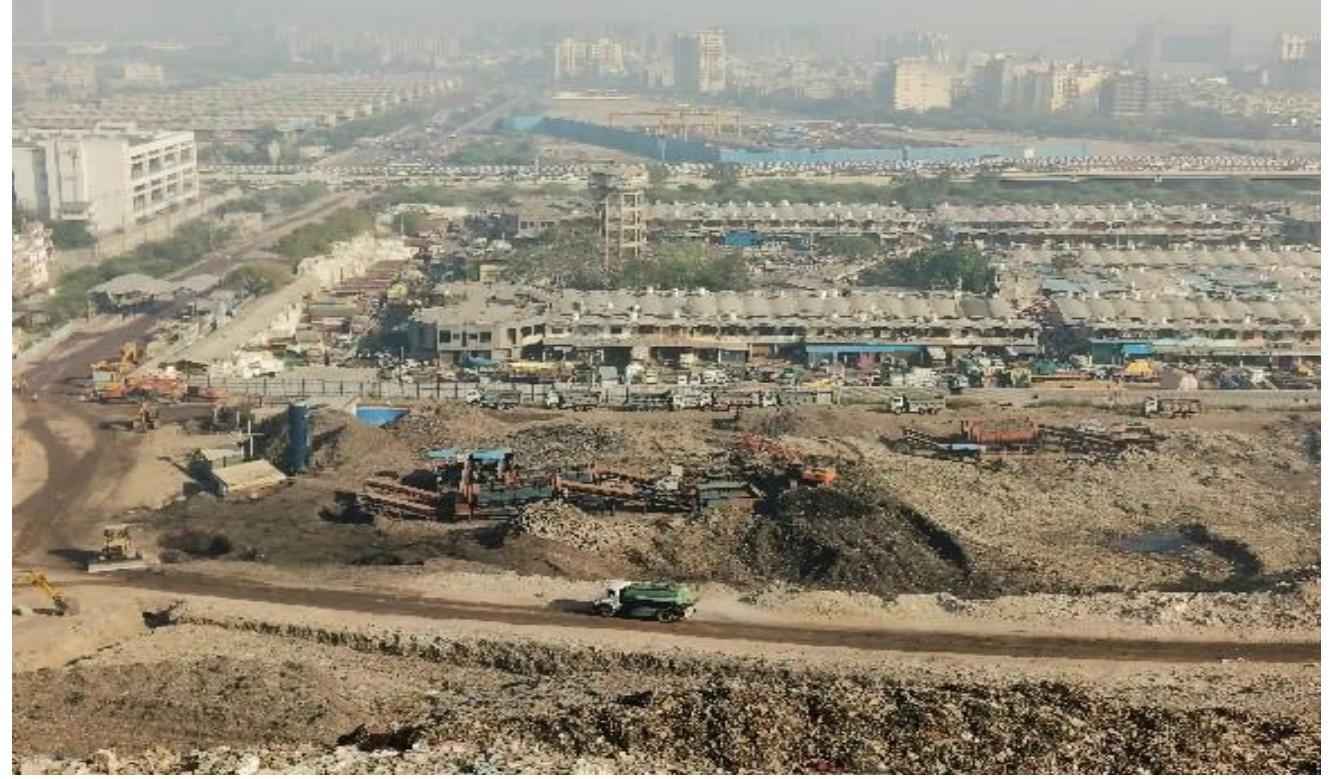
10. On- going Bio mining of waste (at the land claimed to be reclaimed)

**According to MCD, this area is claimed to have 5 acres of land reclaimed from the landfill site. However, based on both a closer inspection and an aerial view, I believe that no land has been fully reclaimed at this location. As seen in the image, the area remains under bio-mining, with two trommels still in operation.

12. Land Reclamation and Bioremediation – Implement bioremediation techniques, including bio-mining and bio-capping, to reclaim land from old landfill sites.

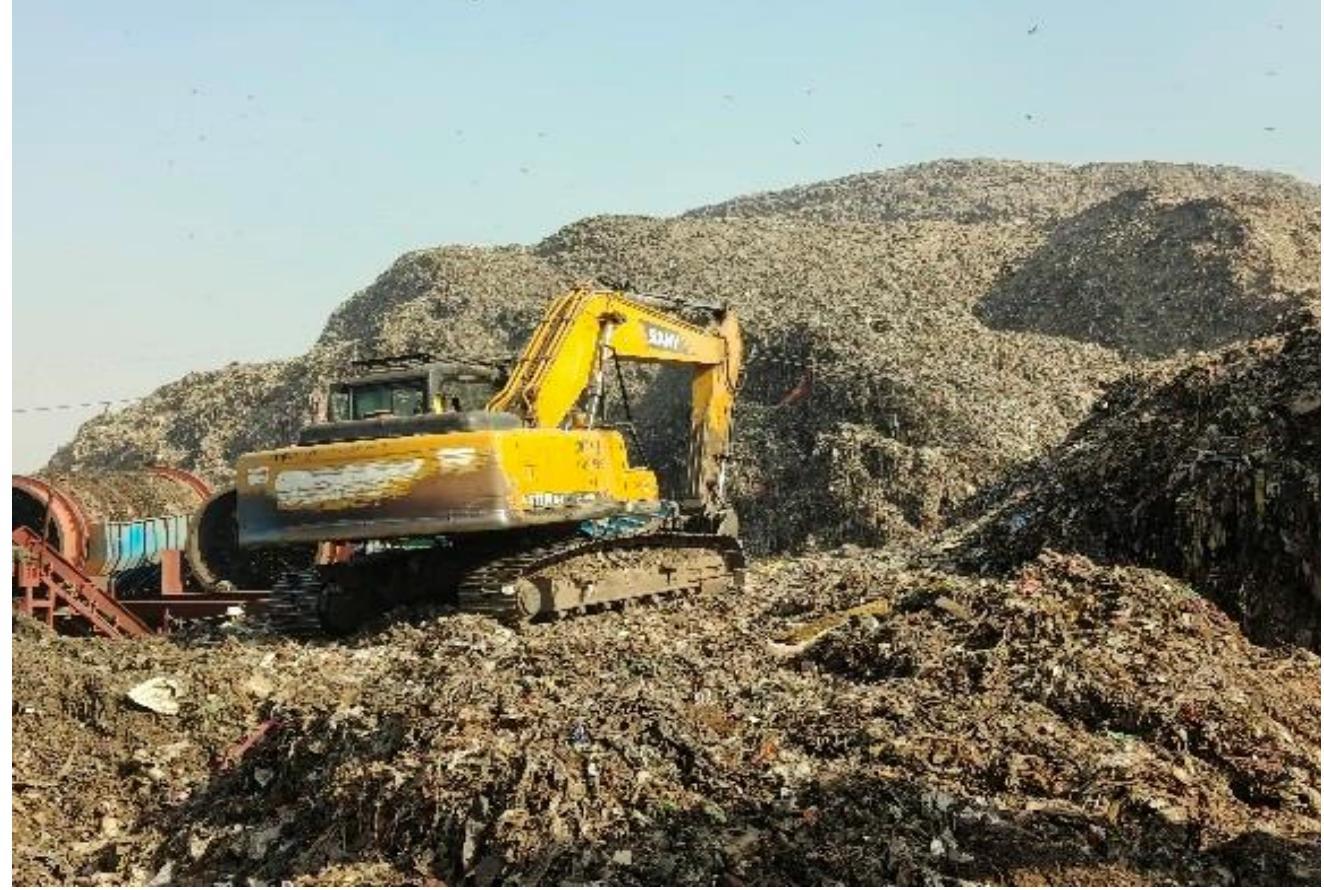
13. Bio Mining of waste

Bio-mining was in progress on the canal side using two trommels. Officials stated that an additional two trommels would be operational soon.

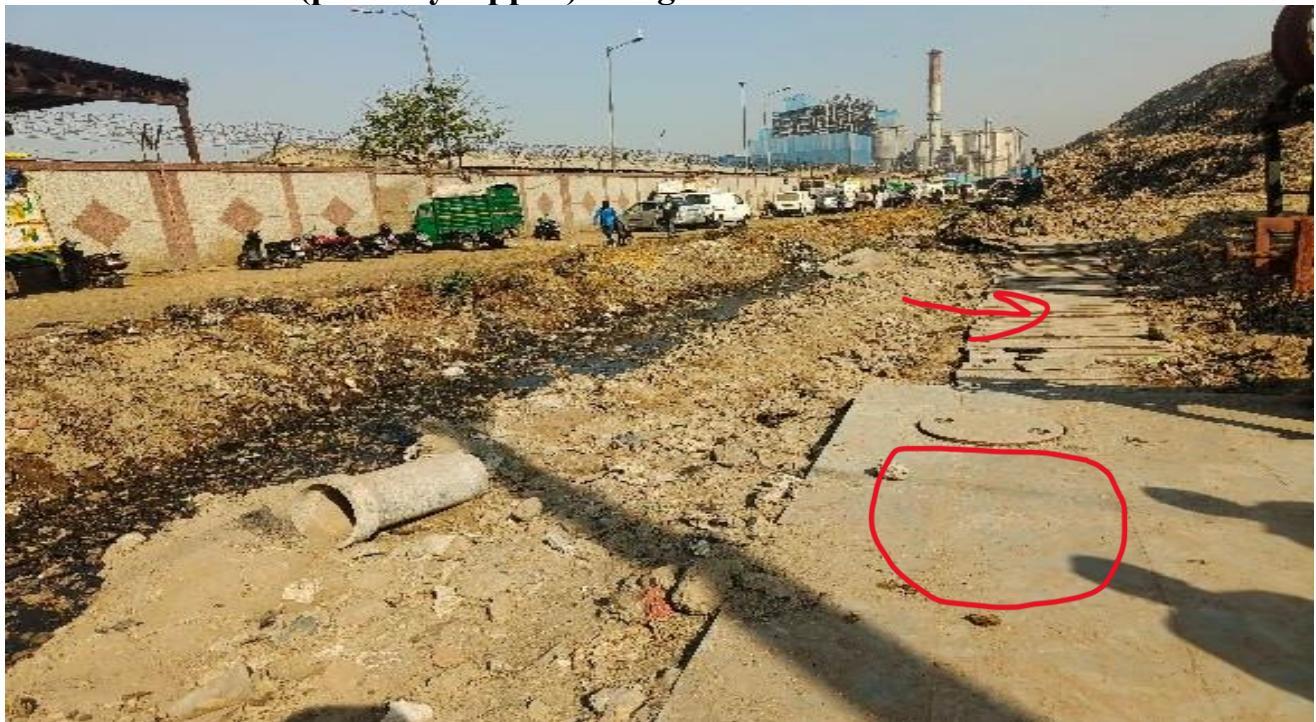
14. Leachate tank (partially tapped) alongside of the livestock drain

A leachate tank was positioned near a small drain by the livestock market/mandi. Although it was claimed that the leachate is being tapped and diverted to the tank, it appeared to be only partially captured.

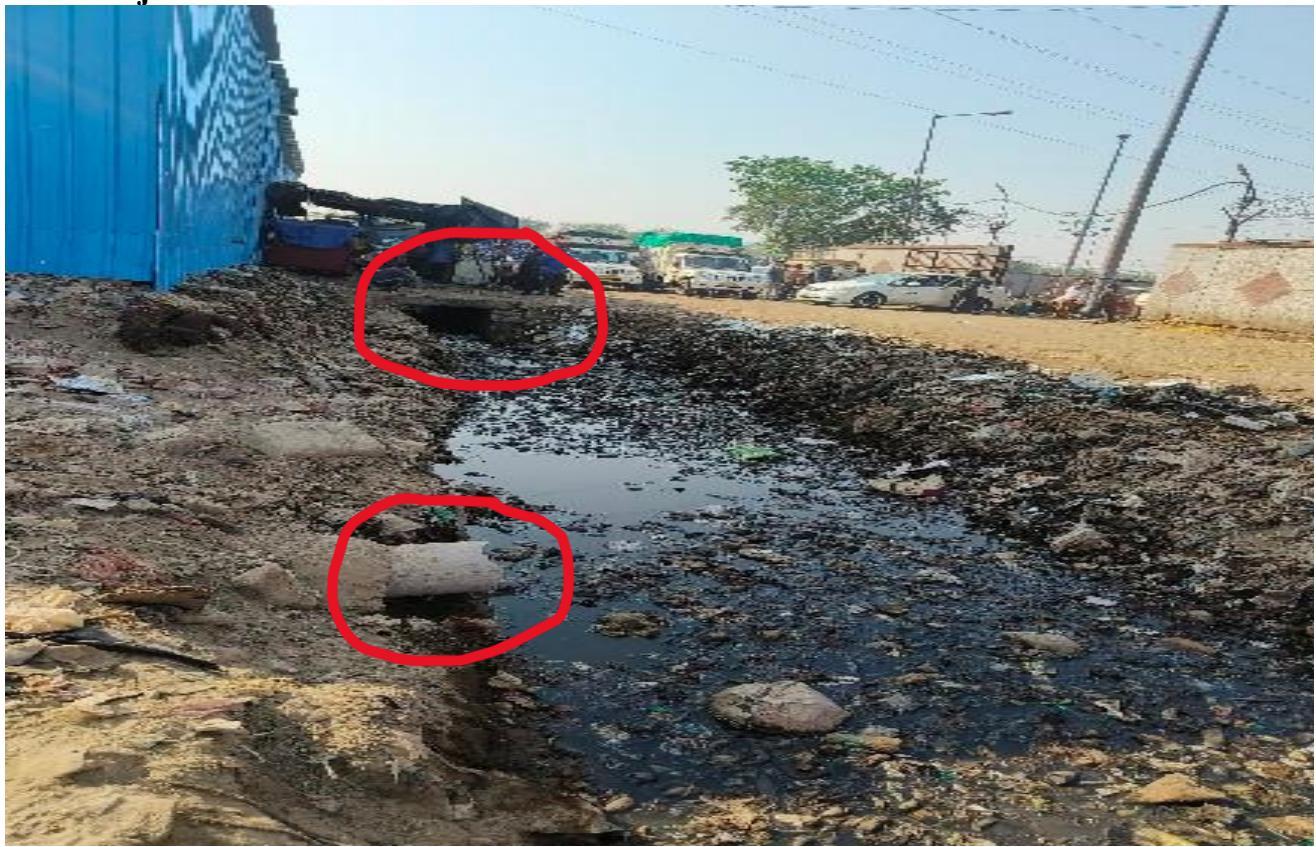
The livestock mandi drain is seen to exit towards Drain No. 1
 A pipe can be noticed protruding out from the leachate tank

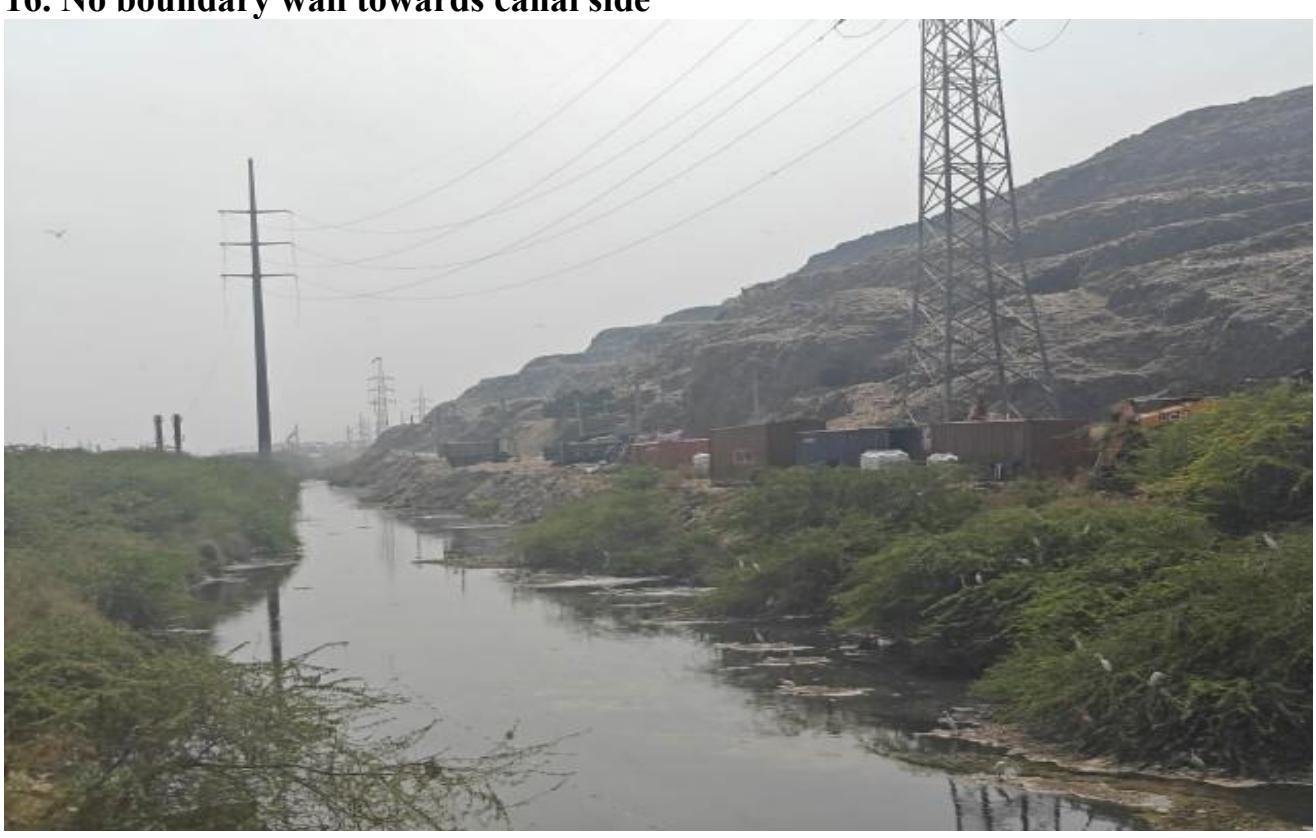
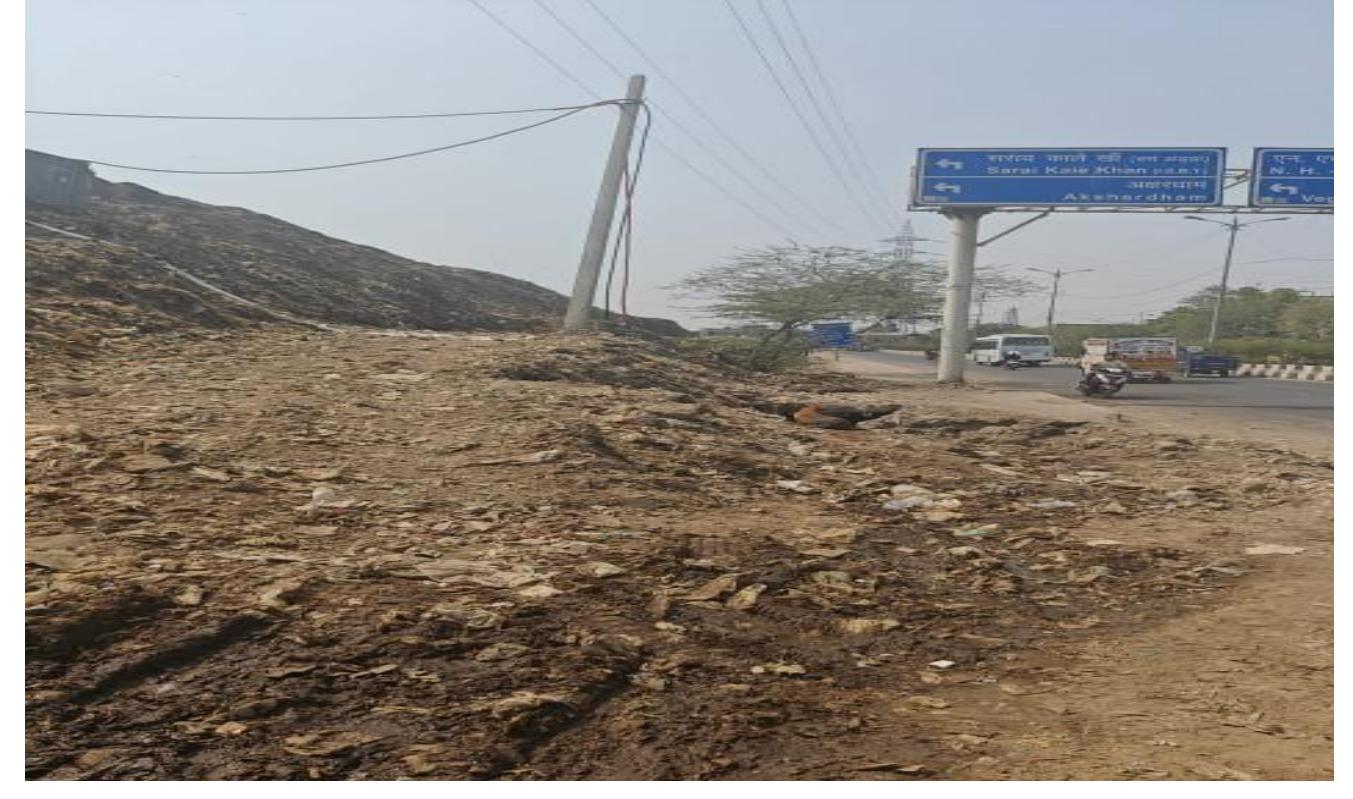
16. No boundary wall towards canal side

17. No boundary wall towards the road (slaughterhouse side)

**At two locations around the landfill site, the boundary wall was missing—one near the Hindon Canal/Drain No.1 and the other near the MCD Slaughterhouse. This poses a significant risk, as a potential landfill slide could endanger people and vehicles. Additionally, the lack of a boundary allows unauthorized access, raising security concerns and the possibility of miscreants igniting a fire.

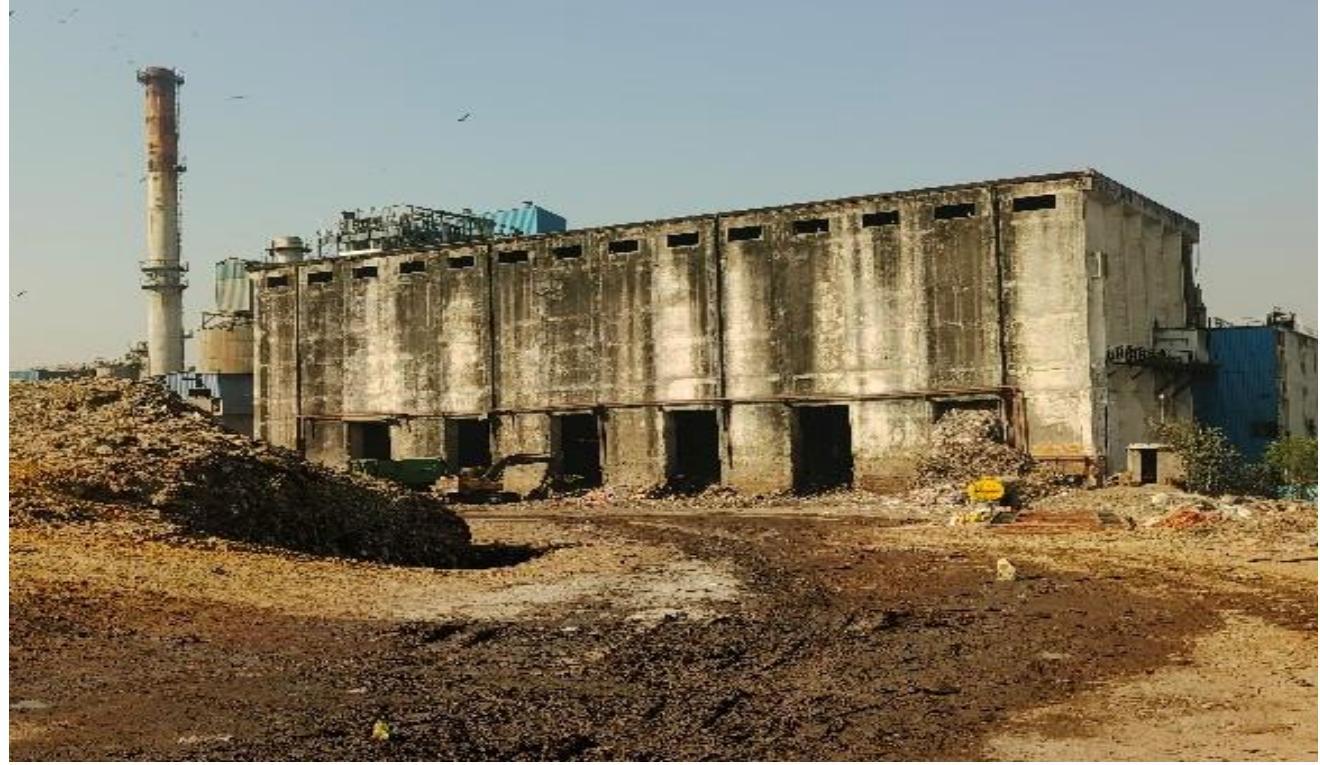
18. Storage of WTE

The storage of the WTE was full (Primary pits and RDF pit- total capacity 16000 tons)

2. Expansion and Optimization of Waste-to-Energy (WTE) Facilities – Increase the processing capacity of existing WTE plants (or establish new), strategically located plants to handle all fresh waste efficiently, reducing landfill dependency.
