## The 18 August 2008 Kosi river breach: an evaluation

### The 18 August 2008 Kosi breach

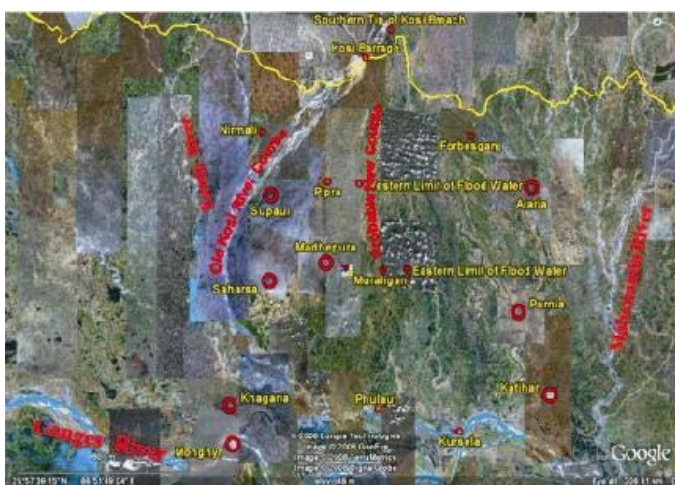
**Figure 1.** Regional map showing the course of the Kosi river (old – pre-18 August 2008, and new) and areas affected by the 18 August 2008 floods.

In the Himalayan terrain, the Kosi river is formed by the confluence of seven smaller streams, viz. Indravati, Sun Kosi, Tama Kosi, Likhu Kosi, Dudh Kosi, Arun Kosi and Tamar Kosi at different places in China, Tibet and Nepal, before its entry into the Indian state of Bihar (Figure 1). In India, the Kosi river merges with the mighty Ganges near Kursela village, Katihar District, Bihar. Kamla, Baghmati (Kareh) and Budhi Gandak are the major tributaries of Kosi in India, besides many minor tributaries like Bhutahi Balan. The river travels a distance of 729 km from its source to the confluence with the Ganga, and drains a total area of about 69,300 km<sup>2</sup>.

spread over a great extent covering Supaul, Saharsa, Madhepura, Araria and Purnea districts, causing severe damage to life and property. In fact, after the 18 August breach, the Kosi river has altogether taken a new course, that of the 1930s, as reported by local residents near Muraliganj.

To get first-hand information, assess the present situation and suggest possible scientific studies/steps to be taken to mitigate future floods, we visited the affected area including the breach point during the 12–16 September 2008. As mentioned by several workers earlier, since the river is flowing from the high-altitude mountains, due to its high gradient, it carries heavy bed load. Once it reaches the plains its velocity reduces to a great extent and the river is not able to carry its load. Apart from that, the river in the downstream of the barrage till its confluence with the Ganga (at Kursela) is flowing about 250 km length in a semi-circular way with a low hydraulic gradient (1 : 5000 m). Due to this, the river is not able to carry its suspended load even after the barrage. The river deposits its load wherever possible and changes its course to lower levels. After the barrage construction, due to its channelized flow, the river started building up the stream bed, resulting in considerable elevation difference between the stream bed and the surrounding areas (in particular in the east). Presently as the river is flowing close to the eastern afflux bund and the material used to construct the embankment is local sandy soil, which makes it easy to breach the embankment as well as to spread the breach up to 2 km within no time. The topographic low in the eastern side of the embankment facilitated the river to select one of its older courses making its route almost like a straight line from Kusaha (at the breaching point) to Phulaut (meeting with Kosi) in about a 120 km stretch.
