### Site Visit Report

**Subject: Inspection of MSW dumping site of Nagarpalika- Valsad at Survey no. 152, near Railway Bridge at Auranga River is carried out with reference to HO mail dated 21/09/2023 in the matter of O.A. No. 57/2023 (Old O.A. No. 540/2022) (Prakashbhai Premabhai Patel & Ors. Versus State of Gujarat).**

#### **Status regarding Solid Waste Management of Valsad Nagarpalika:**

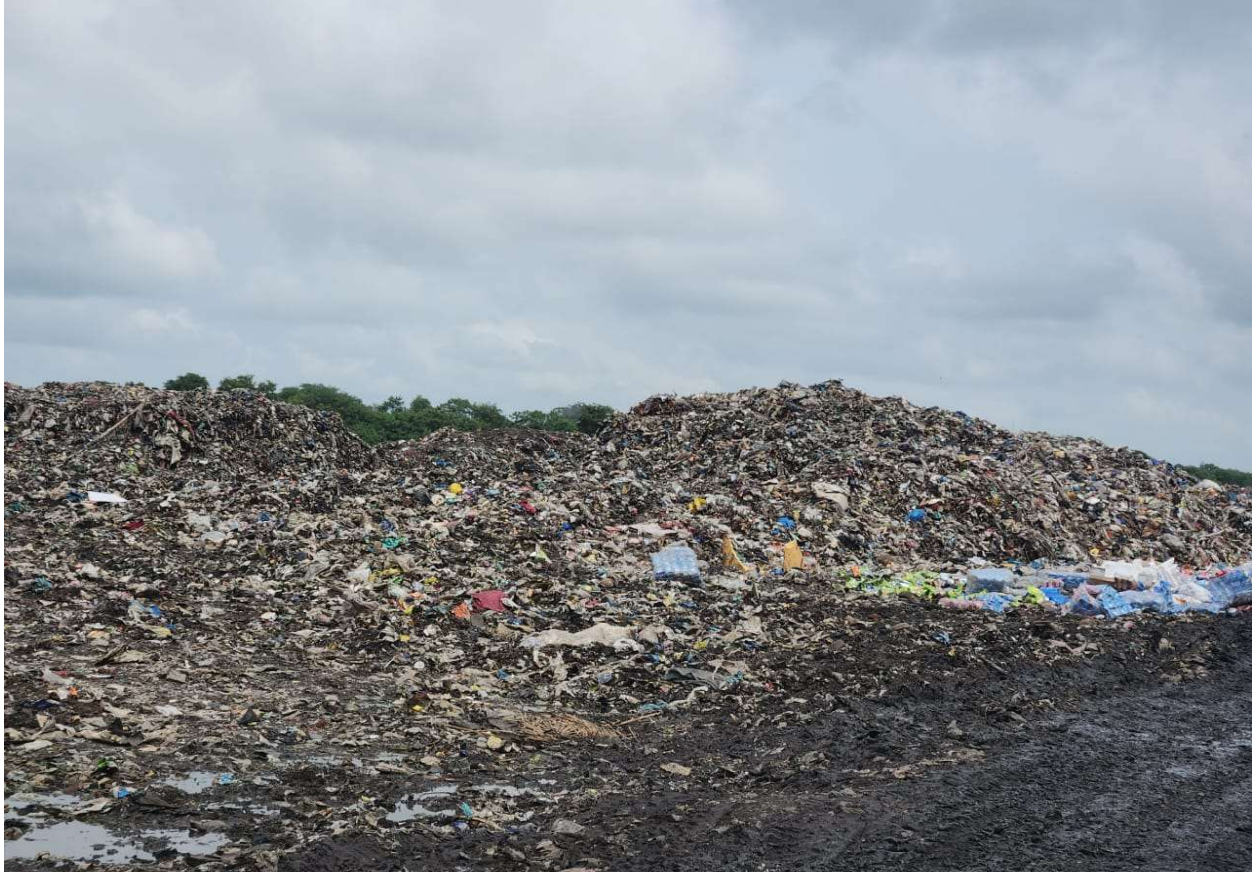
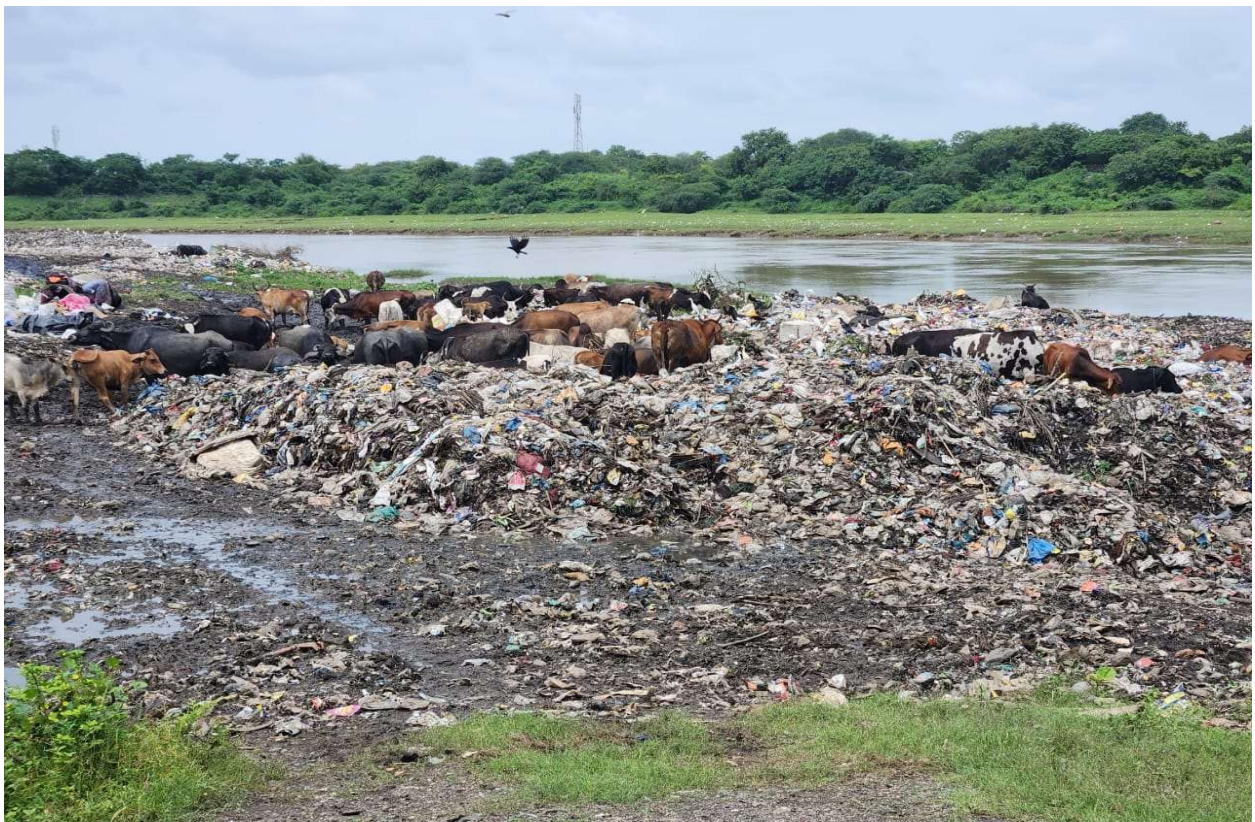
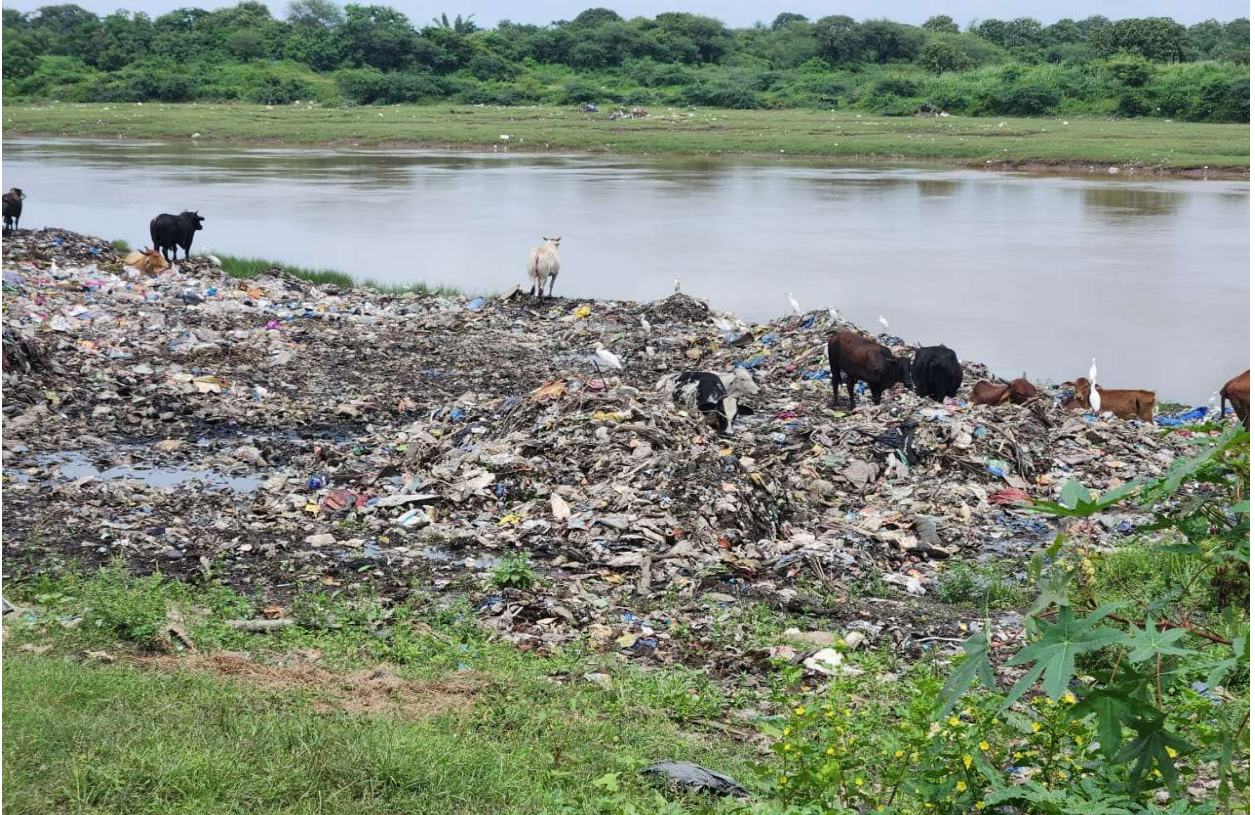
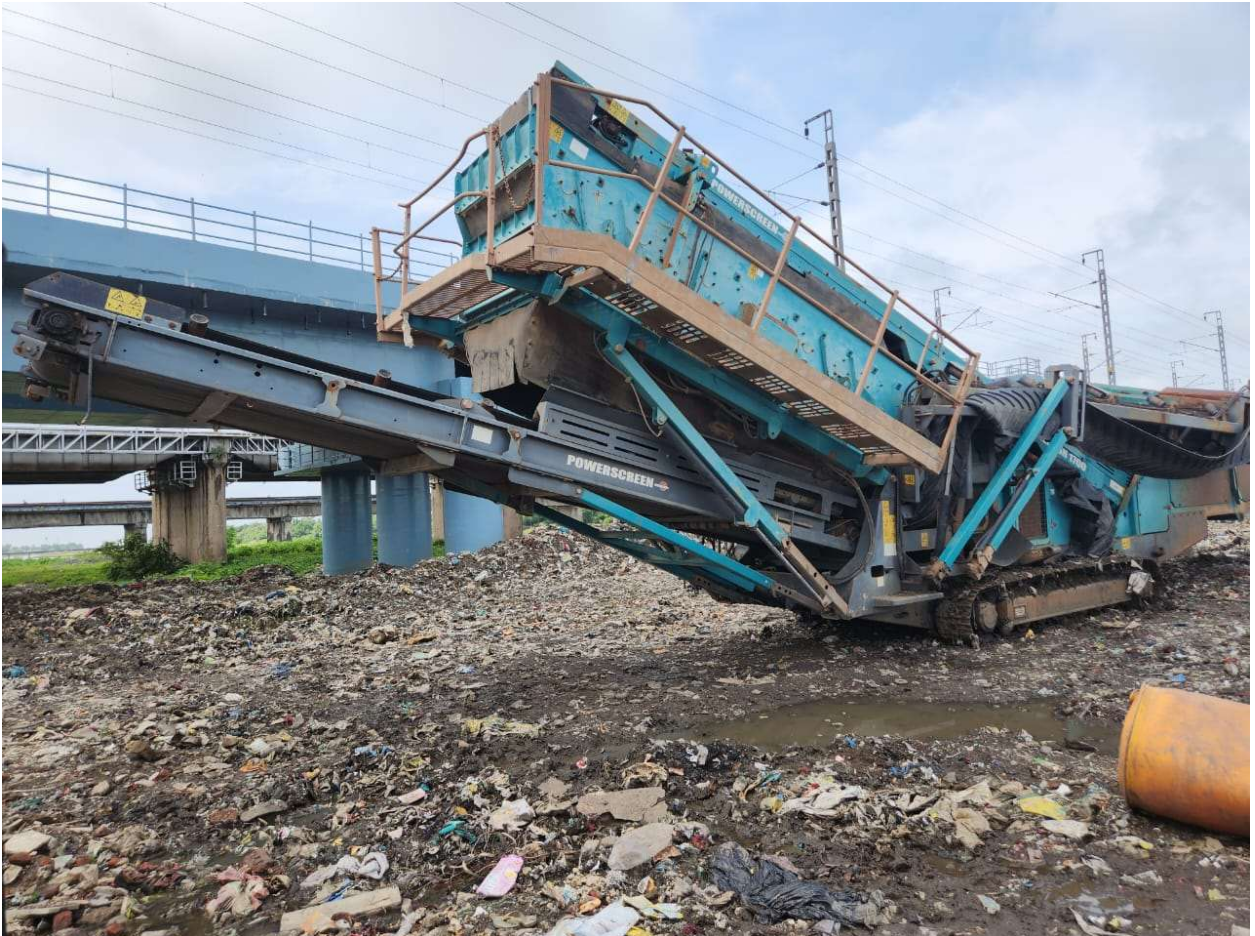
Photographs taken during visit:

- MSW dumping site is located just adjacent to bank of river Auranga. At present they dispose MSW on open land near STP adjacent to Bank of River Auranga.

- MSW received from residential, commercial, hotels & non-residential area of Nagarpalika area and dumped at bank of Auranga River near railway bridge through tractor, tempo. Nagarpalika has stored waste haphazardly at this site.

- One Auto Vibrator Screener is observed at MSW dumping site which is found not in operation during inspection. Till date work is not started for processing of Legacy waste.

- No fencing or Boundary wall is constructed on periphery of dumping site. During inspection Animals grazing observed on MSW dumping site & No waste processing is observed.

1. You shall submit Compliance Report with reference to this office letter dated 30/05/2023 with respect to Hon'ble NGT order dated 05/09/2022 in the matter of O.A. No. 540/2022.
2. You shall submit Progress Report of MSW Fresh and Legacy waste processing.
3. You shall comply with SWM Rules-2016.
4. During inspection Animals grazing observed on MSW dumping site & No waste processing is observed.
5. You shall submit work order of Fresh & Legacy waste processing and also submit completion date of Legacy waste processing.

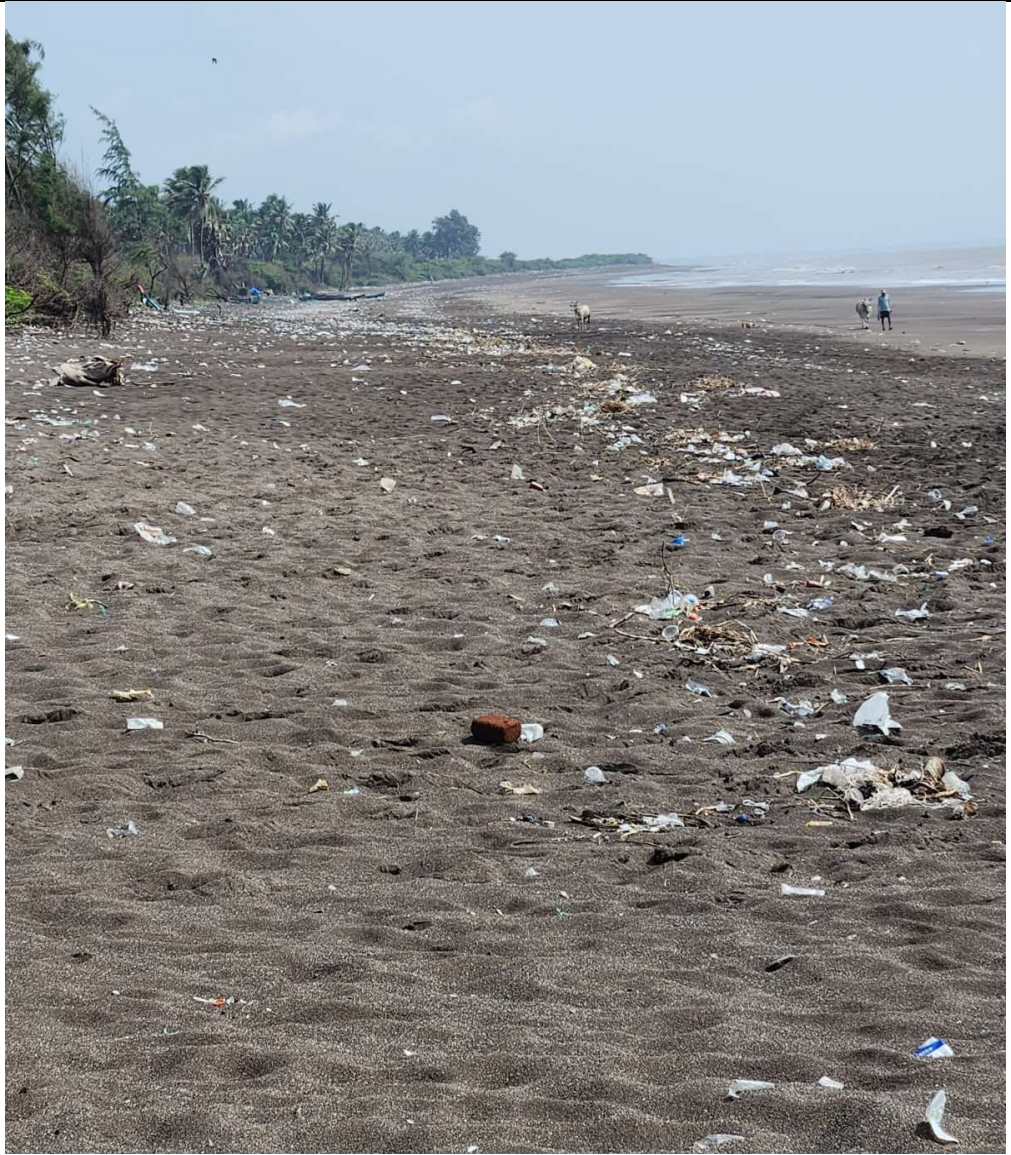
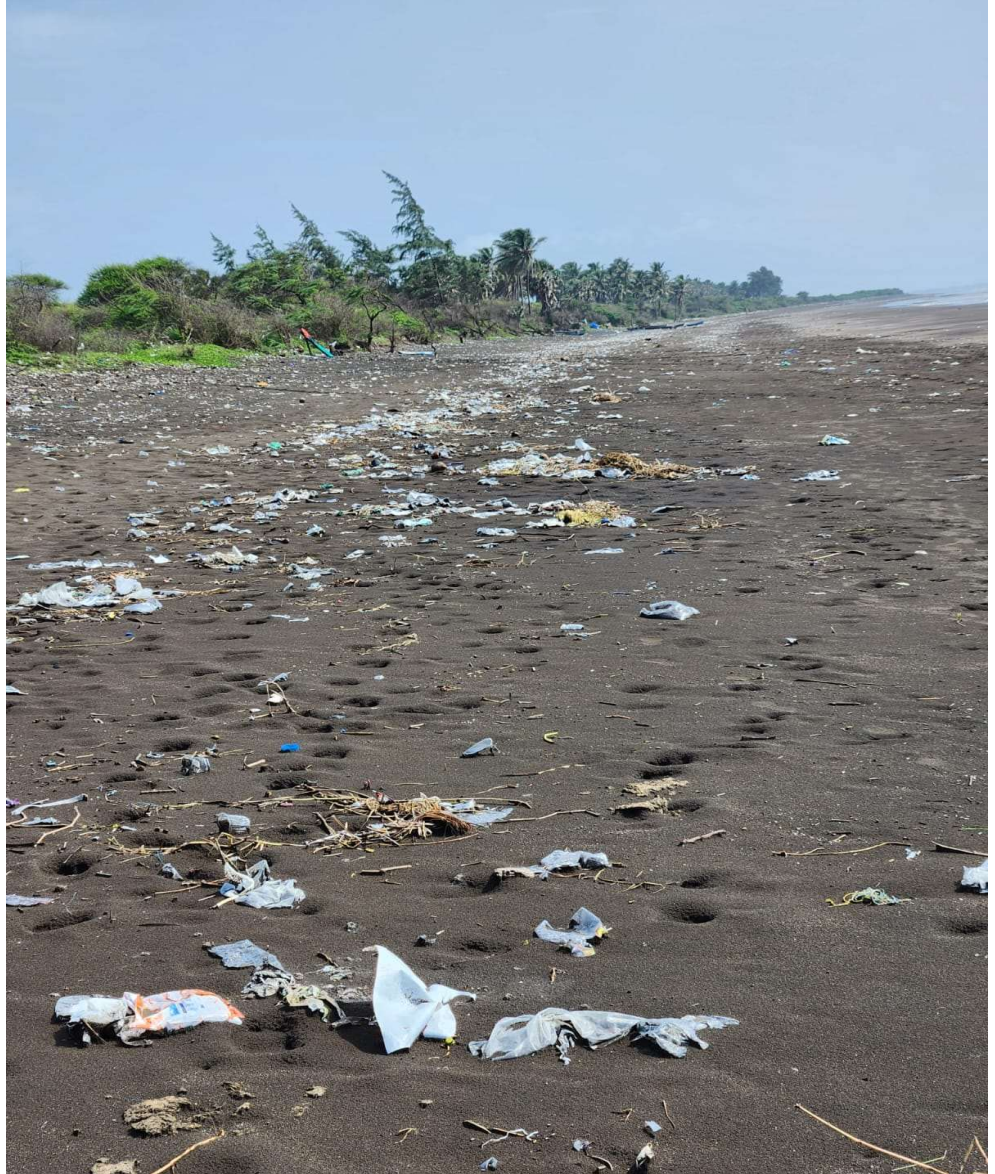
Sr. No.	Name of Village	Observation
1	Bhagad	<ul style="list-style-type: none"> <li>• <b>Contacted person:</b> <ol style="list-style-type: none"> <li>(1) Shree Divyeshbhai Dodiya – Vahivatdar,</li> <li>(2) Shree Jigneshbhai Patel – Computer Operator.</li> <li>(3) Harsadbhai Sukhabhai Patel- Resident of Village-Bhagad</li> <li>(4) Dipakbhai Thakorbhai Patel- Resident of Village-Bhagad</li> </ol> </li> <li>• Plastic waste is observed on shore line of the village Bhagad. Photographs is attached herewith. Quantity of plastic waste accumulation waste deposition at sea shore line is observed higher compared previous inspection dated 31/12/2022.</li> <li>• In Bhagad, at present there is no facility for solid waste collection, segregation, processing and disposal. At present generated solid waste is dumped and burnt by individuals.</li> </ul>

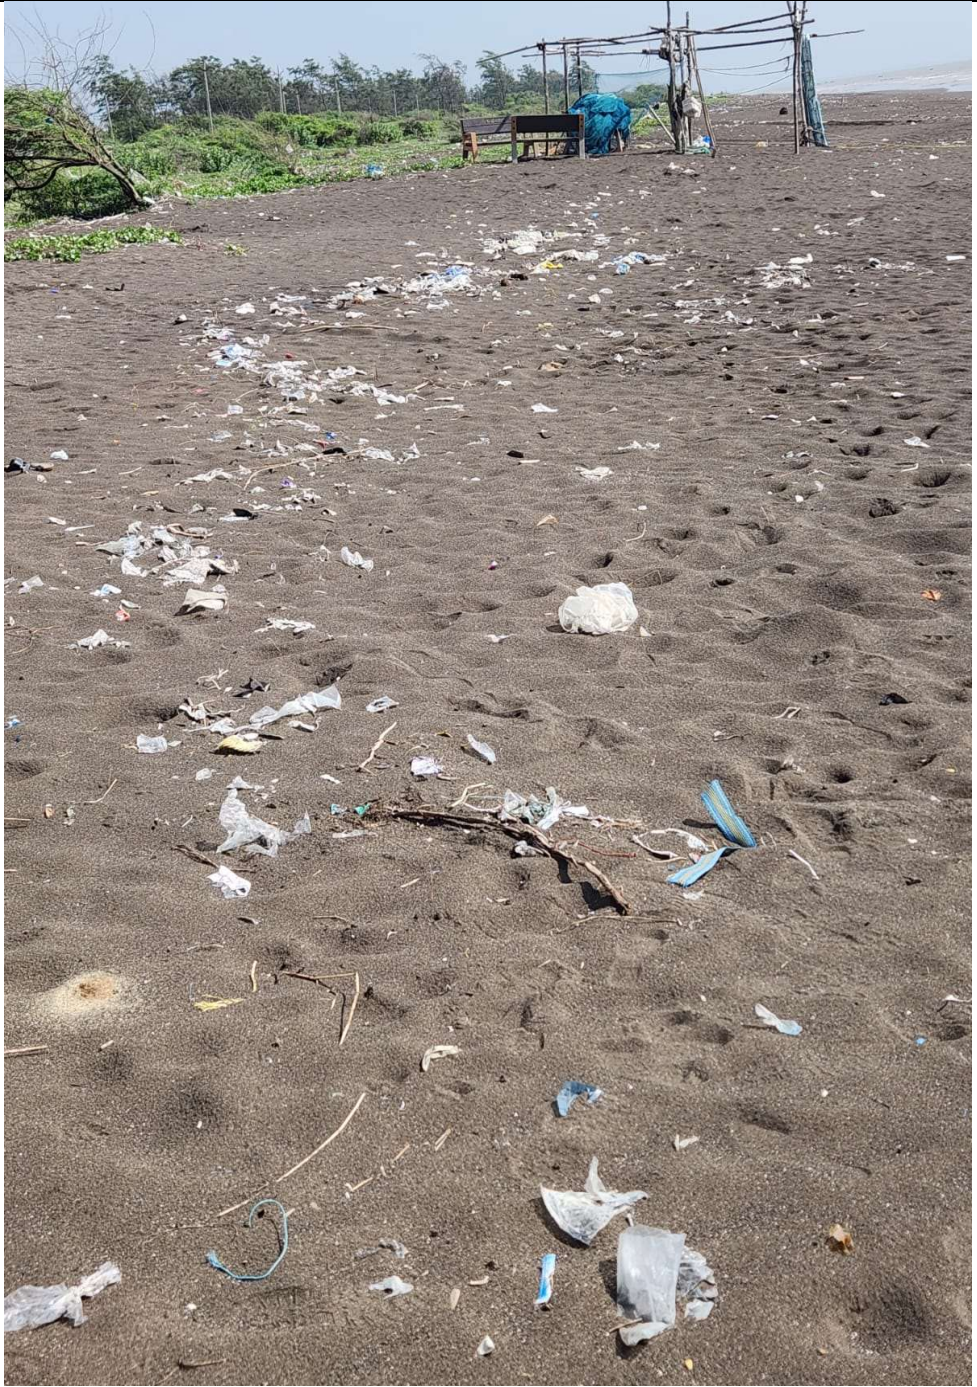
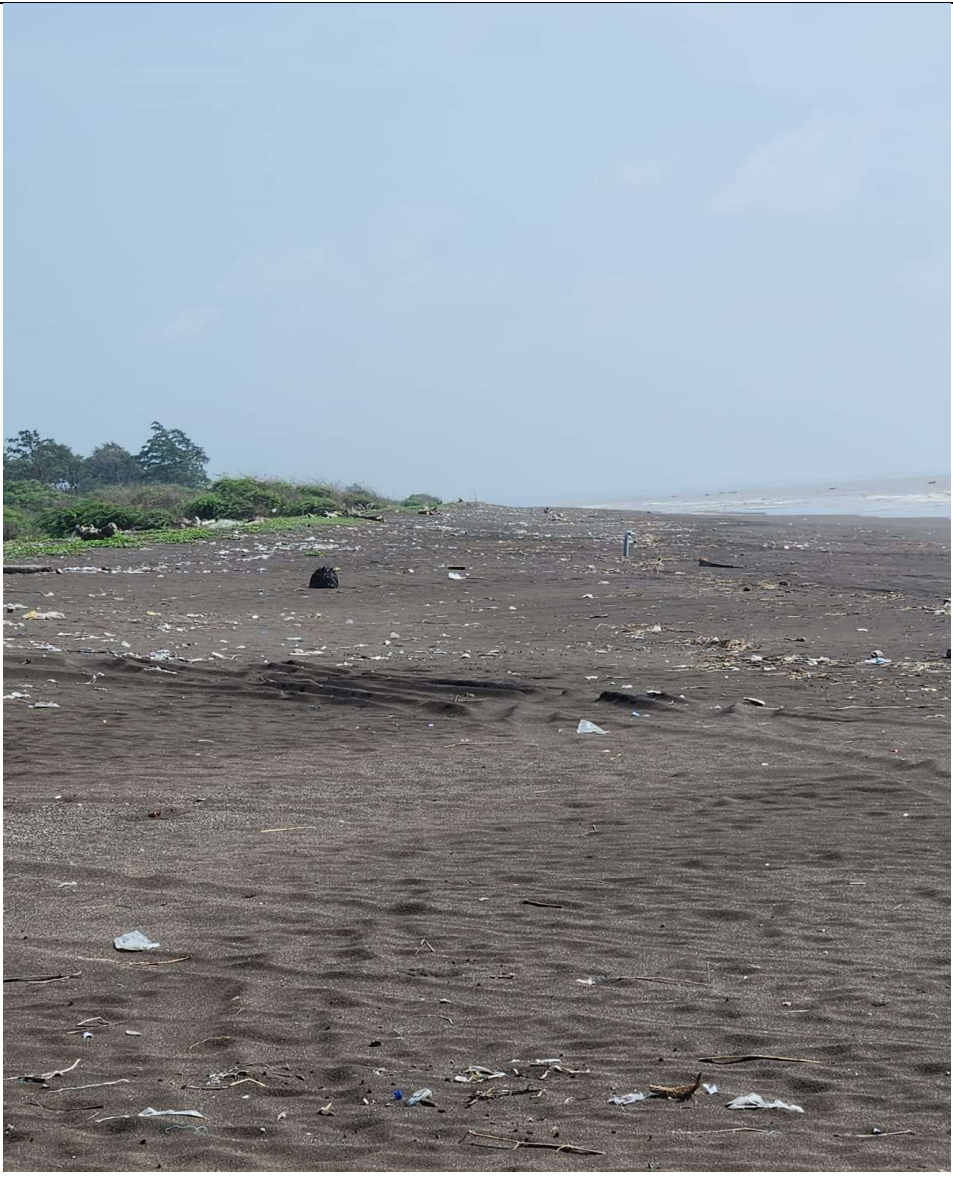
2	Dandi	<p><b>Contacted person:</b></p> <p>(1) Shree Manishbhai - Vahivatdar</p> <p>(2) Shree Jigneshbhai Patel – Computer Operator</p> <ul style="list-style-type: none"> <li>• Plastic waste is observed on shore line of the village Dandi. Photographs is attached herewith. Quantity of plastic waste accumulation waste deposition at sea shore line is observed higher compared previous inspection dated 31/12/2022.</li> <li>• In Dandi, at present there is no facility for solid waste collection, segregation, processing and disposal. At present generated solid waste is dumped and burnt by individuals.</li> </ul>
---	-------	---

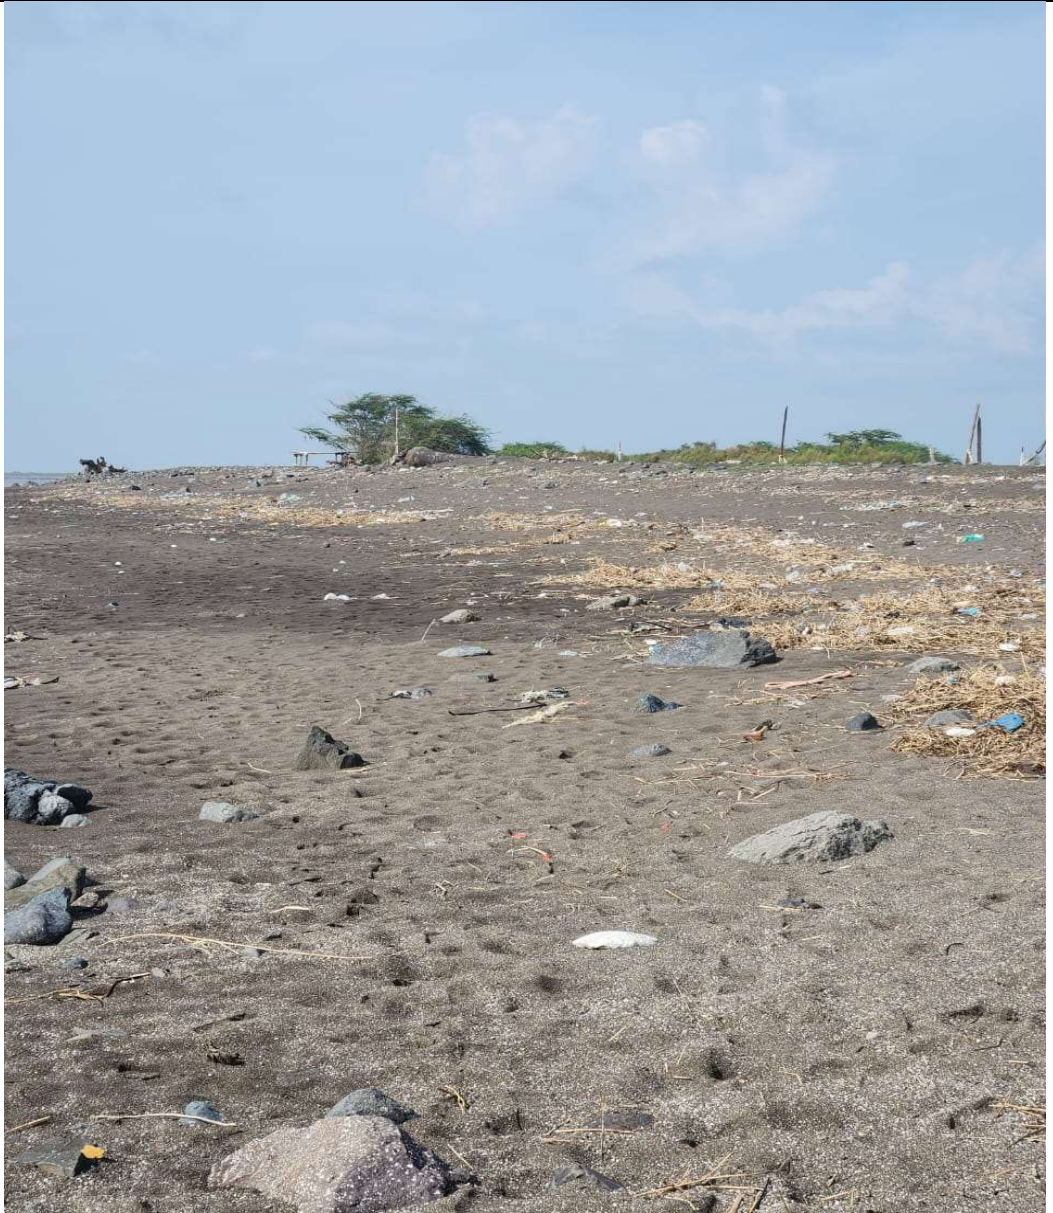
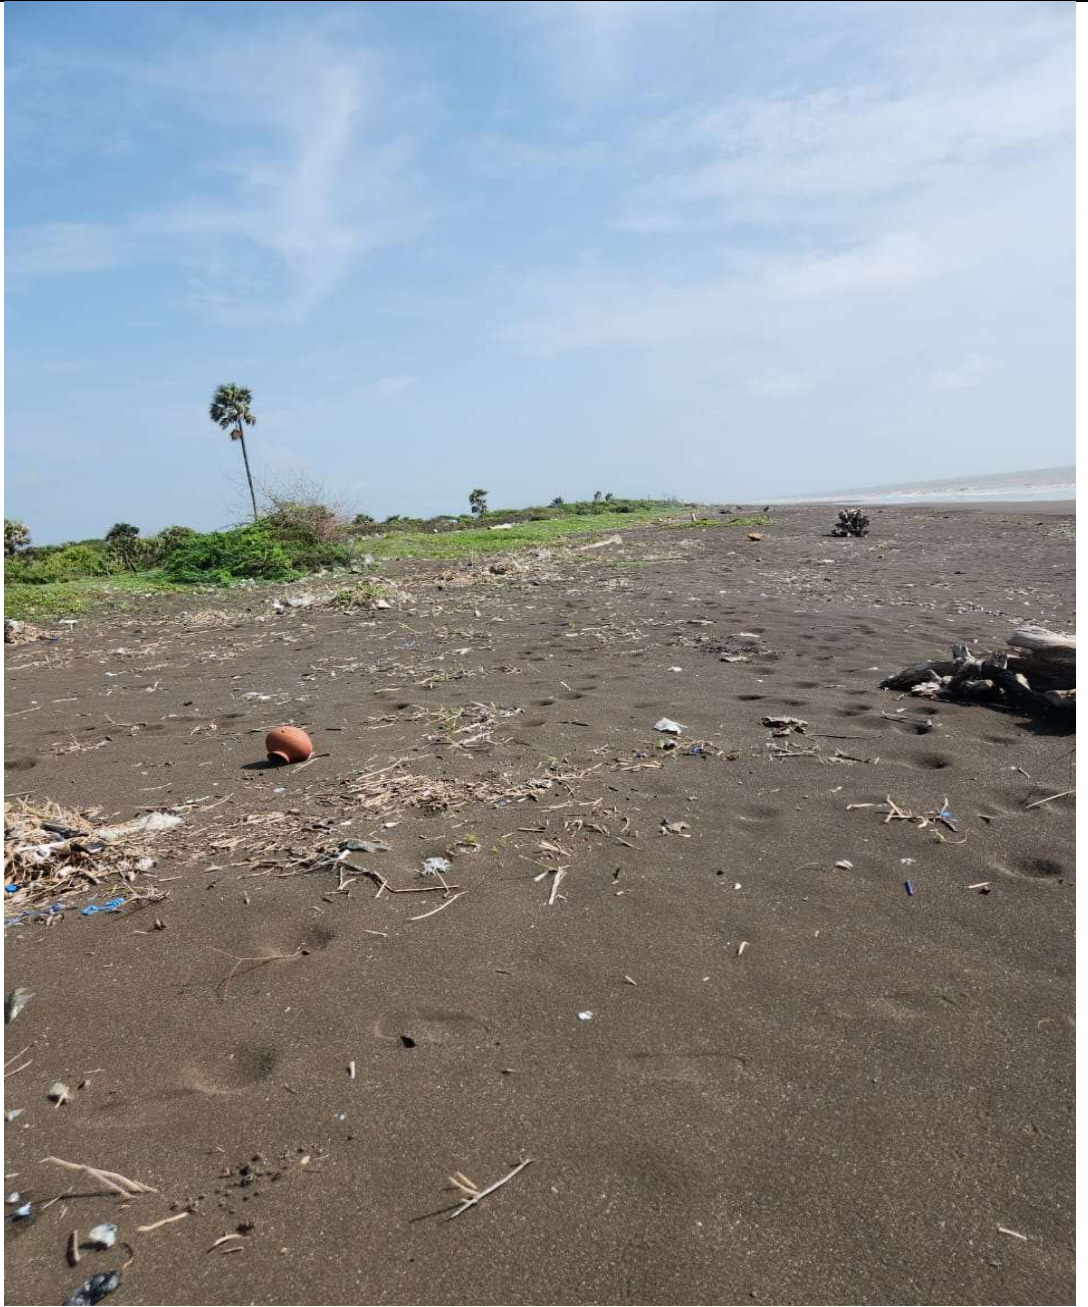
**Moti Danti**

3 & 4	<b>Moti Danti &amp; Nani Danti</b>	<ul style="list-style-type: none"> <li>• <b>Contacted person:</b> <ol style="list-style-type: none"> <li>(1) <b>Shree Amratbhai Tandel – Sarpanch of village Moti Danti &amp; Nani Danti</b></li> <li>(2) <b>Shree Arjunbhai Tandel – Depty. Sarpanch of village Moti Danti &amp; Nani Danti</b></li> </ol> </li> <li>• Minor Plastic waste is observed on shore line of the village <b>Moti Danti &amp; Nani Danti</b>. Photographs is attached herewith. Quantity of plastic waste accumulation waste deposition at sea shore line is observed slightly higher compared previous inspection dated 31/12/2022.</li> <li>• In <b>Moti Danti &amp; Nani Danti</b>, at present there is no facility for solid waste collection, segregation, processing and disposal. At present generated solid waste is dumped and burnt by individuals.</li> </ul>
