Joint Committee Inspection Report

Original Application No.74/2021
'Kailash Kumar Changani Vs State of Rajasthan & Ors'

Date of Visit: 20 October, 2021

Location: Udaipur, Raj.

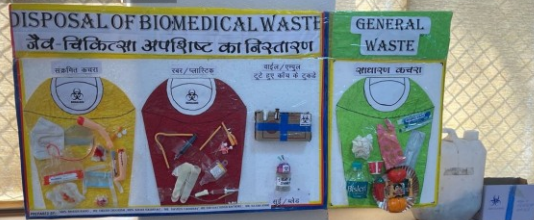
BMW segregation poster

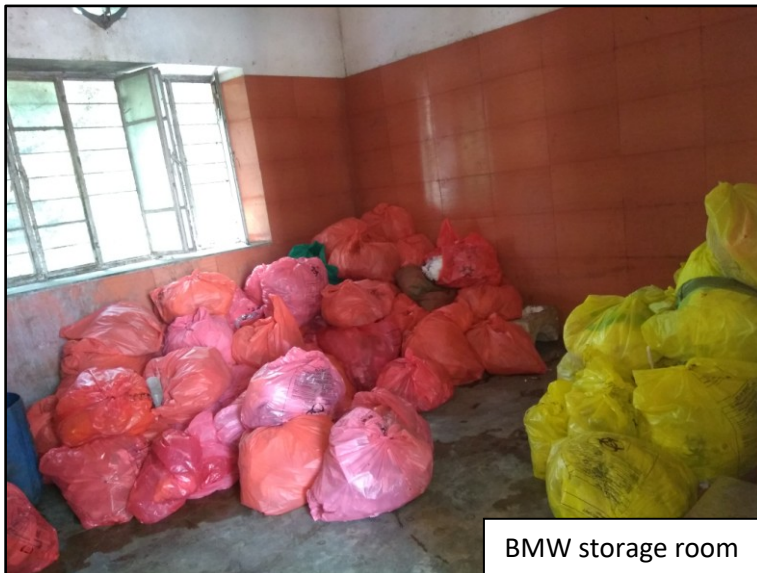
8. The hospital has provided isolated centralized BMW storage facility. It was observed that the BMW and MSW are being stored separately but at common location hence the possibility of interchanging of waste bags may not be ruled out. The hospital administration has unknowingly purchased

BMW storage room

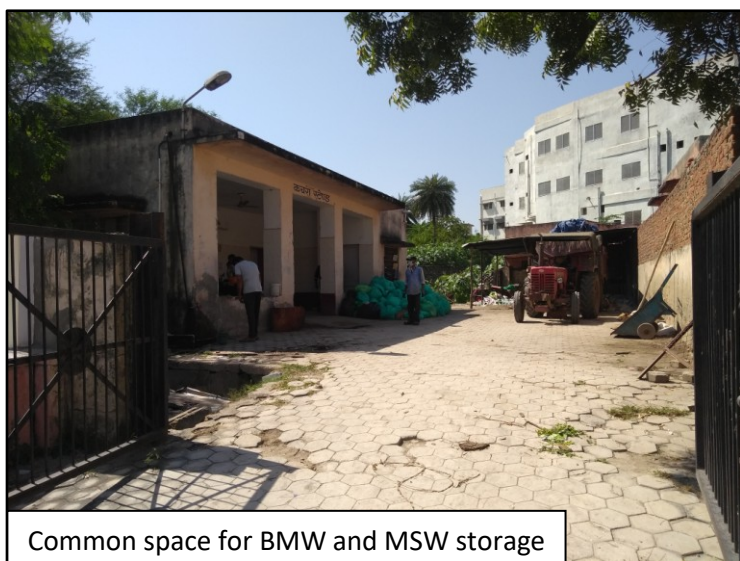
Common space for BMW and MSW storage

1. The BMW and MSW must be stored at different location to avoid any mixing or interchanging of bags.
2. Hospital administration may coordinate with RSPCB regarding organizing awareness and training program at department level w.r.t. segregation, collection, storage, and proper documentation.
3. The BMW must be collect in designated color bag as given in schedule-I of BMWM Rules, 2016.
4. The consent and authorization must be obtained from RSPCB at the earliest.
5. Bar code system must be adopted for waste tracking.
6. Documentation of waste management must be maintained properly.
7. Strict instruction may be given to waste contractor and supervisor regarding proper on site segregation and collection.
8. Special training may be given to sanitary workers and outsourced staff for better management of BMW.

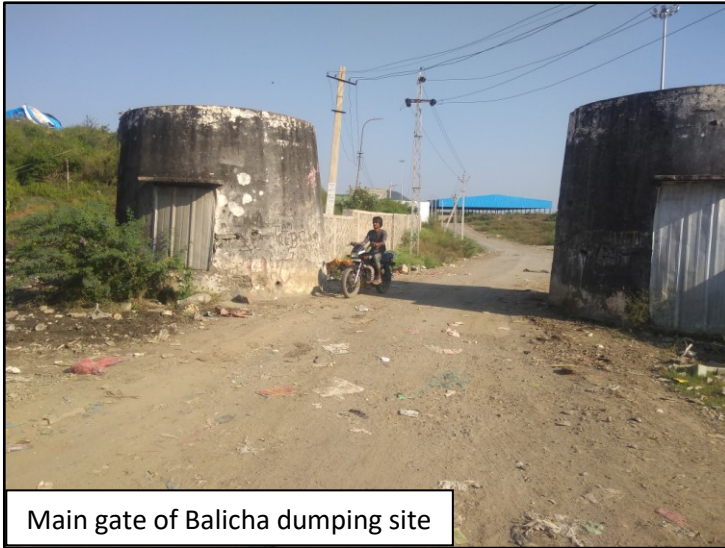
1. The team also visited Balicha dumping ground to verify illegal dumping of BMW and it was observed that it is open dumping ground and there is no fencing around it.
2. Complaints related to dumping of BMW at this site was also published recently in local news paper in this regard Regional Officer RSPCB take self

Main gate of Balicha dumping site

1. Fencing work at the periphery of the dumping site must be completed at the earliest.
2. For disposal of house hold BMW a agreement must be signed with CBWTF.
3. Computerized record of waste and vehicles may be maintained at dumping site.
4. If any illegal BMW received at site then the information should be given to RO,RSPCB and M/s En-vision Enviro Ltd. immediately.
5. Sign board of waste characterization may be placed at prominent location of site for awareness.
6. If BMW found in any collection bin inside the city the action must be taken as per rule.
7. Possibility of CCTV installation may be explored for better monitoring round the clock basis at the dump site.

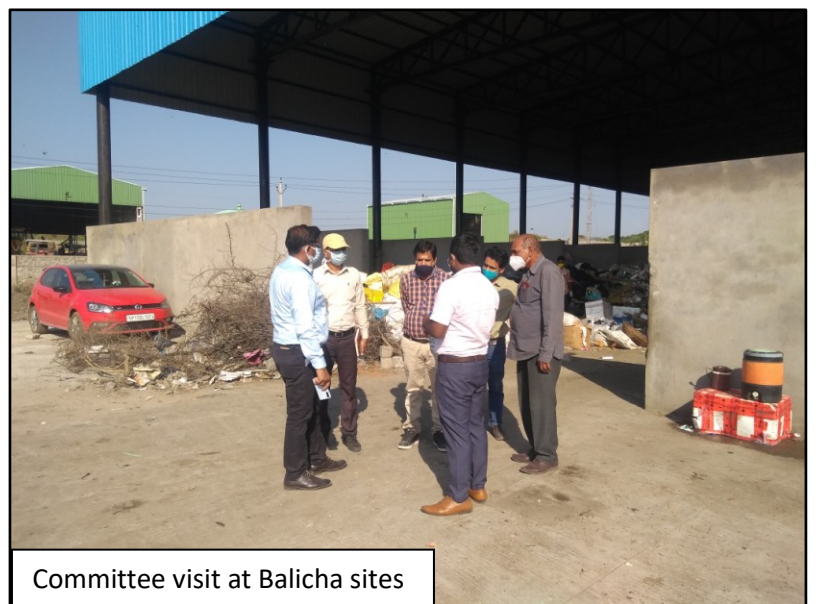
Committee visit at Balicha sites

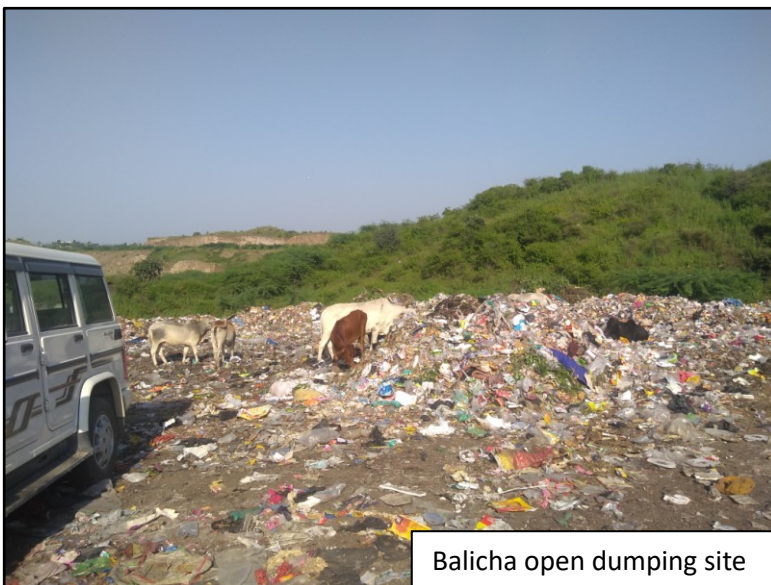
Balicha open dumping site

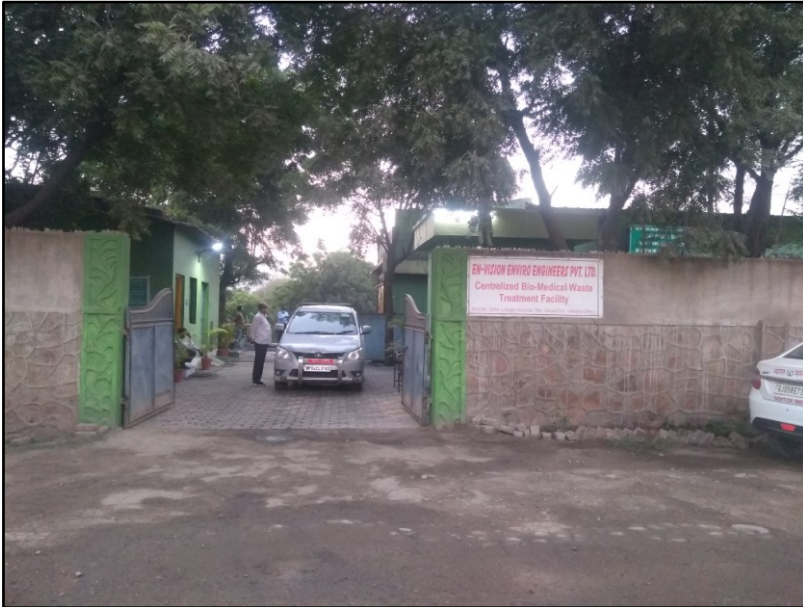
View of M/s Envision Enviro (CBWTF)
Udaipur

4. Possibility of higher capacity of incinerator and autoclave installation may be explored with all necessary permission from RSPCB or other concern agency.
5. To maintain all the logbooks properly and temper proof related to incineration system, waste movement and collection system and treated waste disposal.
6. To organize more awareness programs and interaction meet with member hospitals so that waste could be segregated properly at source.
7. To maintain all the safety measure and good housekeeping at all the time.
8. The unit shall comply all the condition as given in authorization.

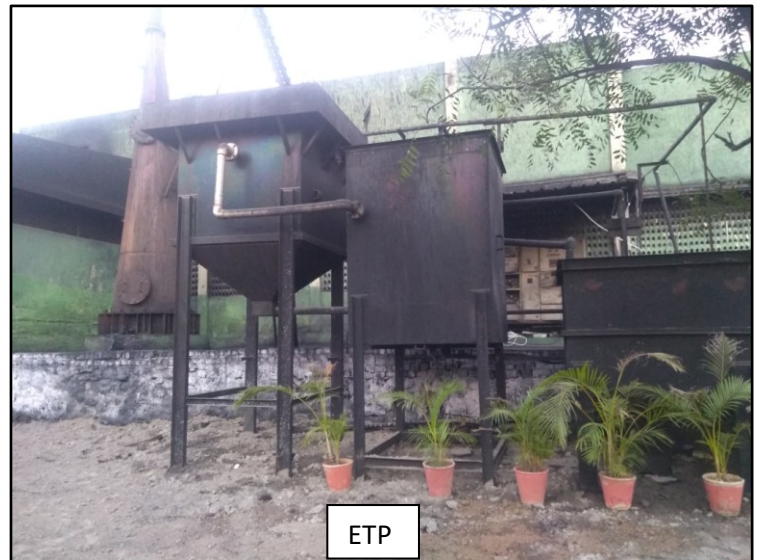
13. For the treatment of waste water generated from floor washing, vehicle washing and scrubber, the unit has provided 5 KL capacity ETP which comprised of Oil and Grease trap, Chemical dosing tank, coagulation Chamber, Primary Settling Tank, secondary settling Tank, PSF & ACF, Disinfection Tank. As informed by operator treated water is stored in overhead tank and further used in horticulture and gardening purpose.

ETP

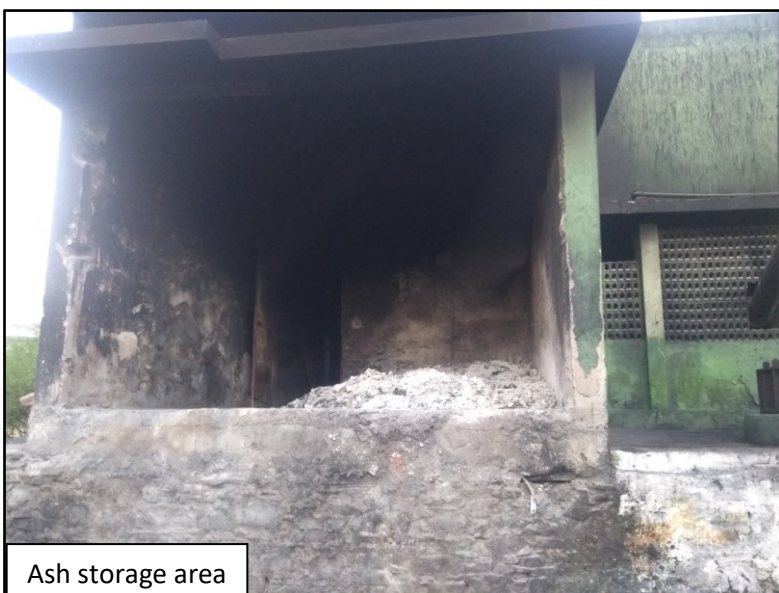
3. The unit has obtained authorization under HW Rules for generation of incineration ash. As informed by the unit representative recently they have disposed 3.98 MT of ash through TSDF, Gudli on 4.10.2021. It was observed still 1 to 2 MT of ash still stored inside the room for disposal. The unit has displayed the hazardous information board at main gate of the unit but it was not updated properly. Copy of the manifest enclosed as **Annexure-07**

Ash storage area

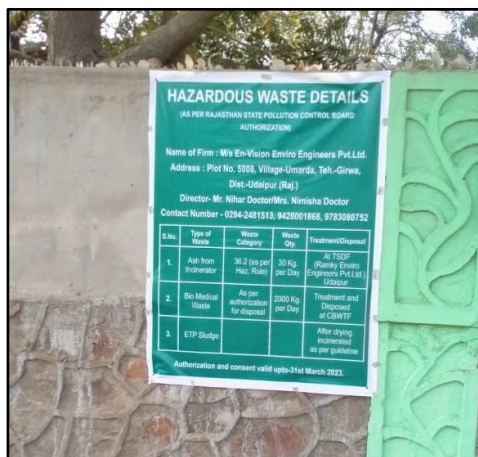
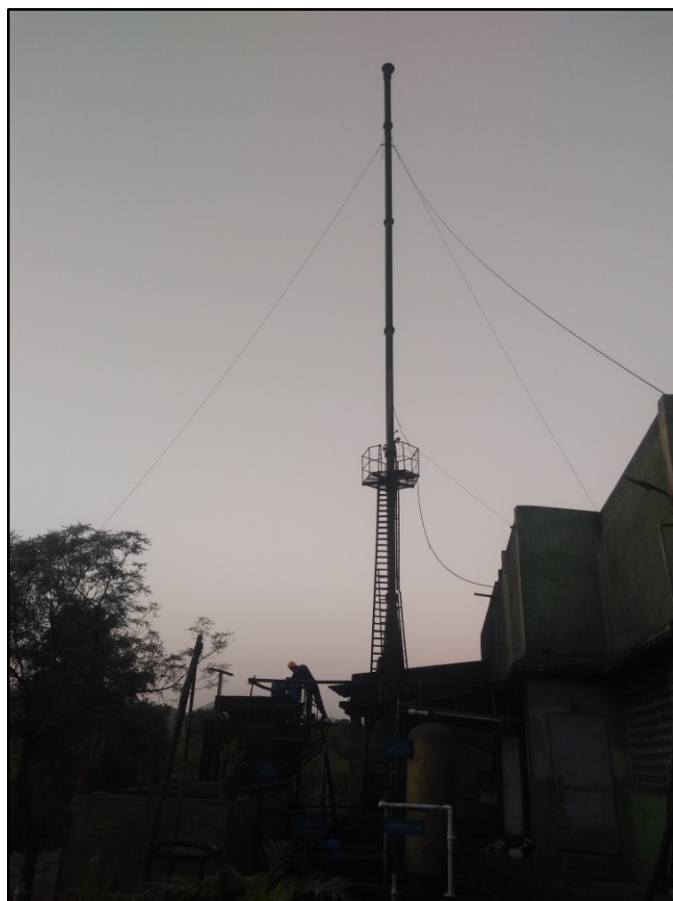
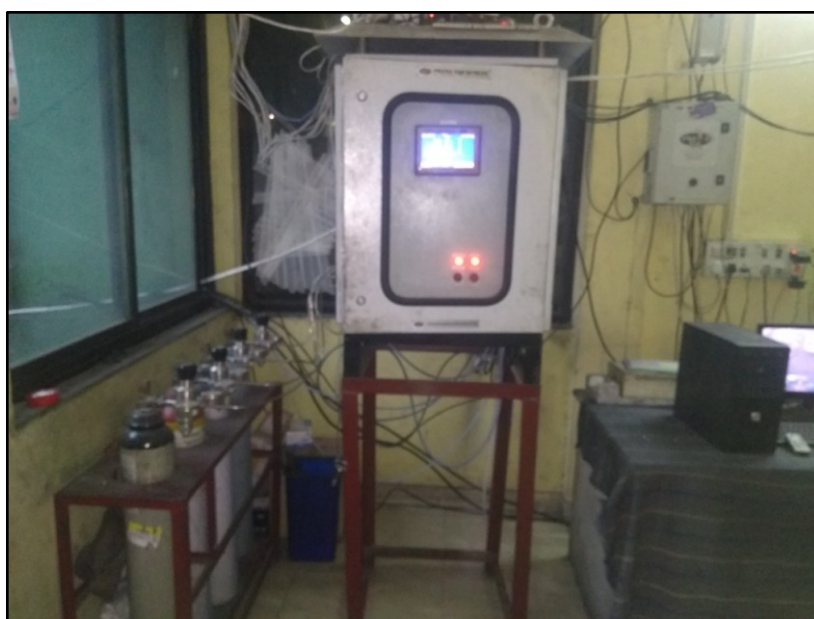
11. The incinerator is found equipped with Air Pollution Control Device (APCD) which comprises ventury scrubber, demister attached with 30 meter stack. The water is used as the medium in ventury scrubber to suppress the dust emission from laden flue gas. The dust emission trapped in the water is collected as sludge in the settling tank.

1. As per the guideline of CPCB, the unit has installed M/s Prima, make CEMS in incinerator stack to monitor primary & secondary chamber temperature, CO and CO₂. The CEMS data available at CPCB and RSPCB website which was verified during visit. The OCMS data sheet for the duration of 1.10. 2021 to 21.10.2021 enclosed as **Annexure-06**
2. During inspection, it is informed by the CBWTF that data is being transferred to the RSPCB/CPCB server through internet but due to poor internet connectivity in this area data transfer is sometimes hampered.
3. The unit has started the bar coding facility but its implementation at ground level was found poor. As per the record most of the HCFs are still not adopting the bar coding system due to lack of awareness in the matter. However implementation of the bar code system is the joint responsibility of the Occupier as well as Operator of a CBWTF.

View of Stack, OCEMS and Hazardous display board at site
